11.0 Appendices

Technical Memorandum

2022 OREGON TECH GEOHERMAL CONDITION ASSESSMENT

Submitted By:
Fluent Engineering, Inc.
June 28, 2022

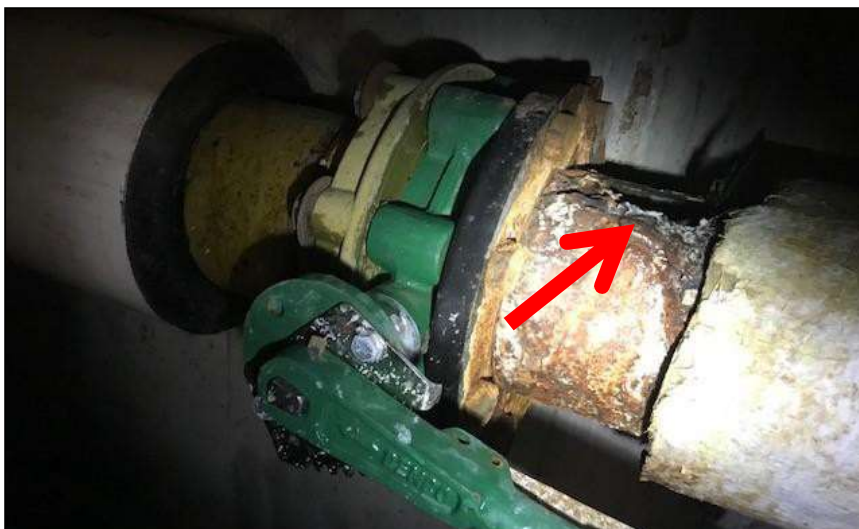
FIGURE 4: RUPTURED PIPE IN TUNNEL

An example of this occurred on June 14th, 2022. A break from a corroded section of pipe ruptured leaving the campus without water for building heating or domestic hot water.

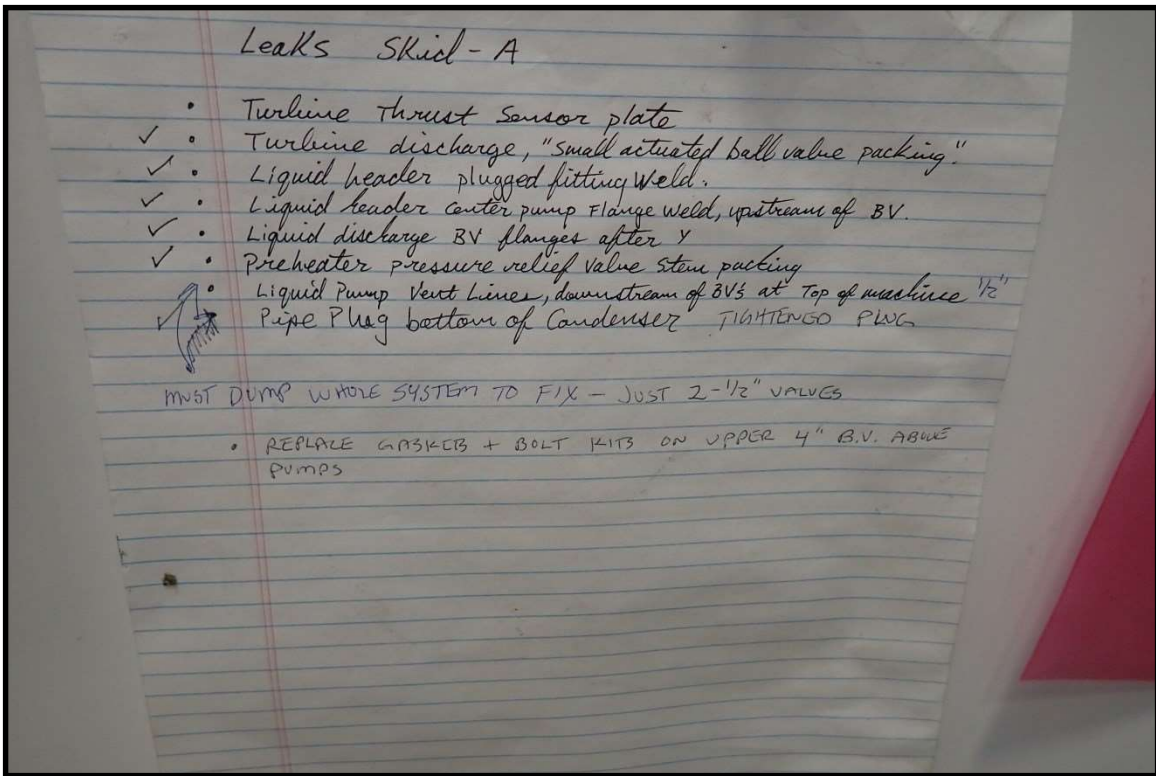
Figure 15 Documentation of leaks inside door of control cabinet

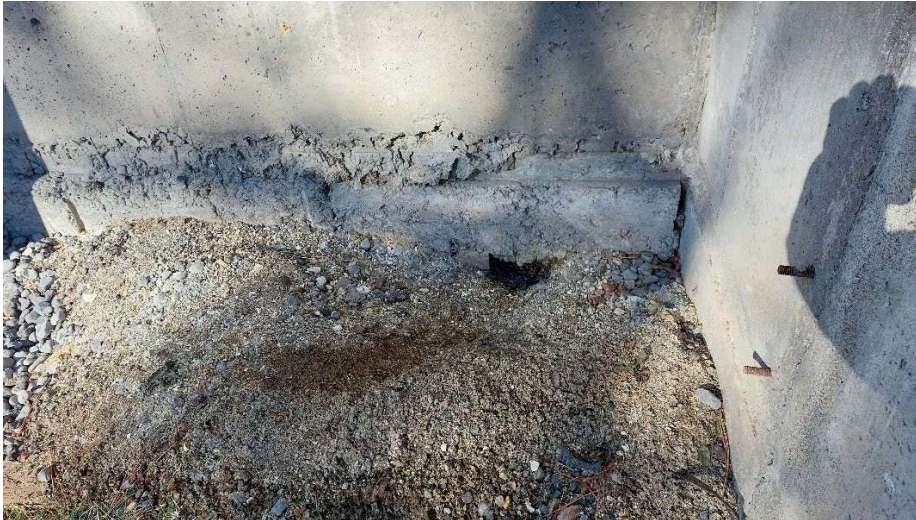
Description Concrete structural elements seem to be in good condition with the exception of the ground floor southwest corner of the building. Here the floor slab has subsided in the restrooms and the subsidence is visible at the exterior. While fallen brick cladding was replaced after the 1993 earthquake, no other structural upgrades were completed at that time. Without this the building does not meet current seismic safety codes and poses a risk to occupants in the next large earthquake.

Condition Assessment Poor.

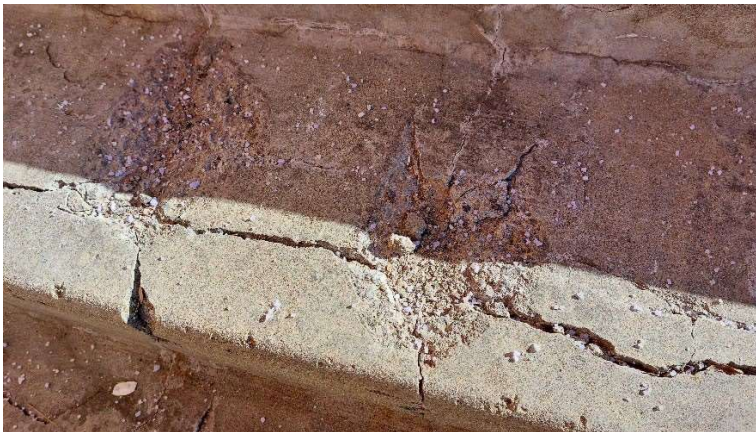
South Stairs

Condition Assessment: south stairs are cracked and spalling. Concrete slabs have heaved probably due to freezing and thawing of expansive soils. Brick paving has heaved in some places and disintegrated at others.

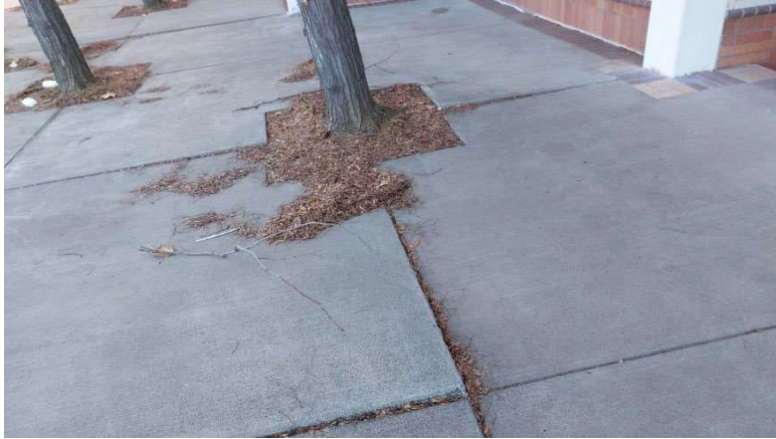
Frost heaves at slabs

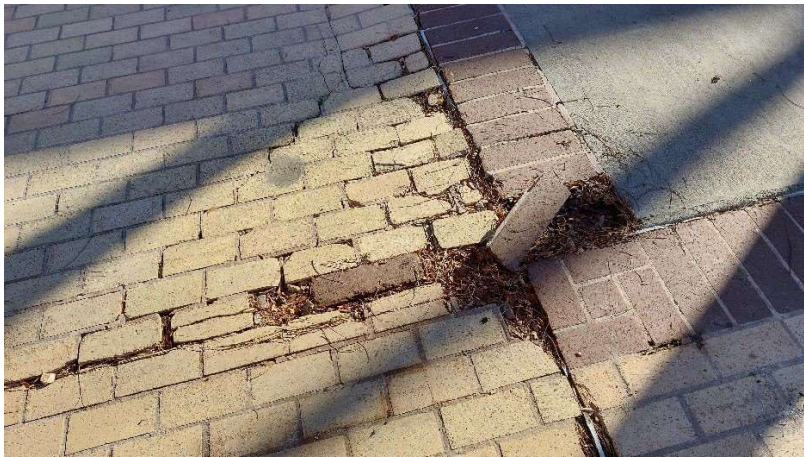
Broken brick paving

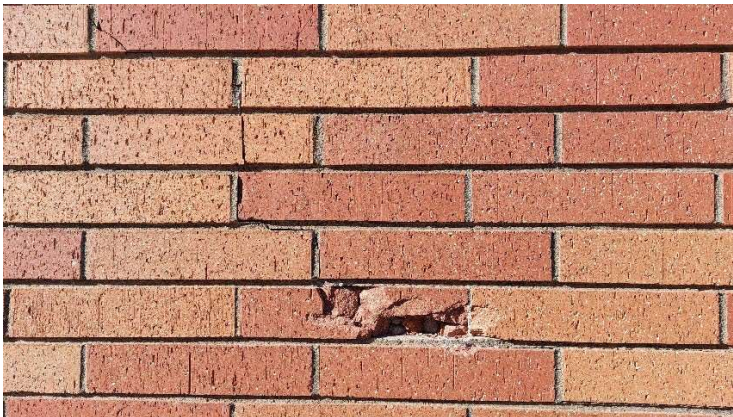
Description Brick cladding is generally in good condition except for one location at the east wall, where there is damage due to either a high velocity impact or possibly a seismic event. There is no apparent water penetration and no urgent need to repair the damage.

Condition Assessment Good.

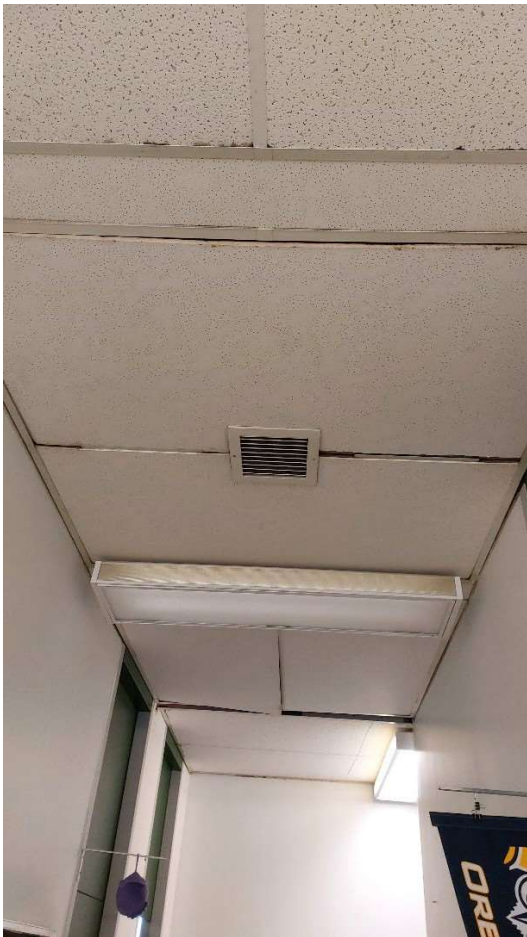
Condition Assessment Fair, poor at select locations. Location below is an example. This is at the dental clinic area. Because of the age it is unlikely that they meet current seismic codes.

Element State: Fair to poor.

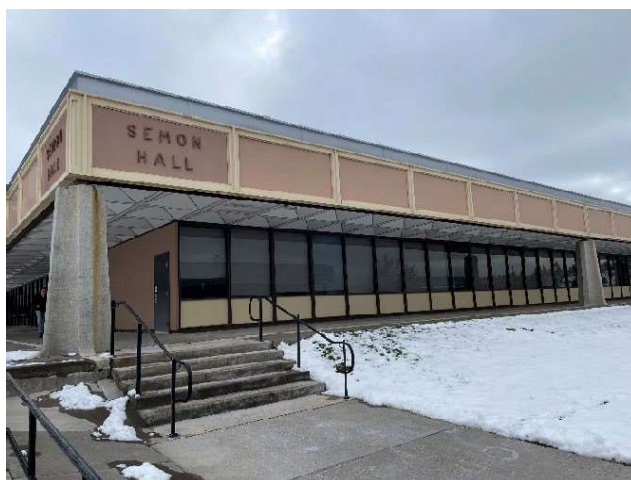
Figure 1: Upward Deflection at Eave

Event Justification & Strategy: The building structure should be upgraded to comply with current seismic codes for the safety of students, staff and faculty, as well as clients of the dental clinic. The approach used should be the one used in the Boivin renovation, rather than the one used in Owens. The Boivin renovation has respected the original mid century modern design of the building while the Owens ignored it and introduced new materials and forms not seen on any other campus buildings.

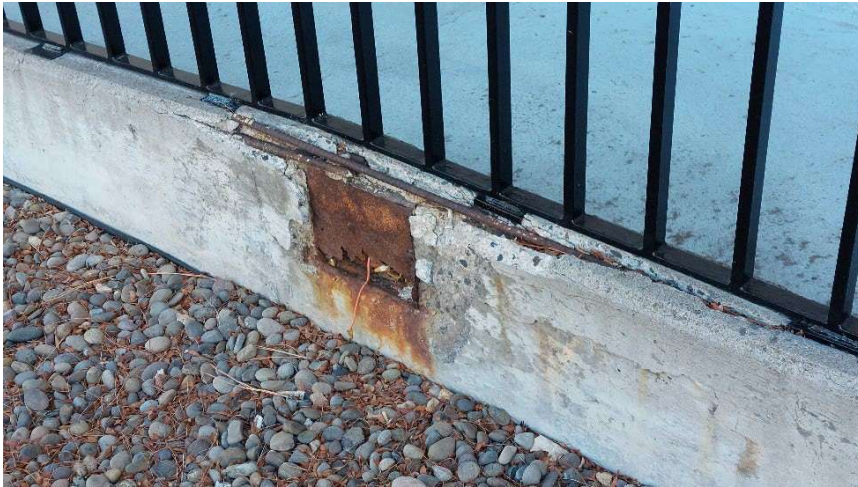
02.03.10 Exterior Walls – East Entry Ramp

Description Accessibility ramp to east entry has exposed rebar and spalled concrete.

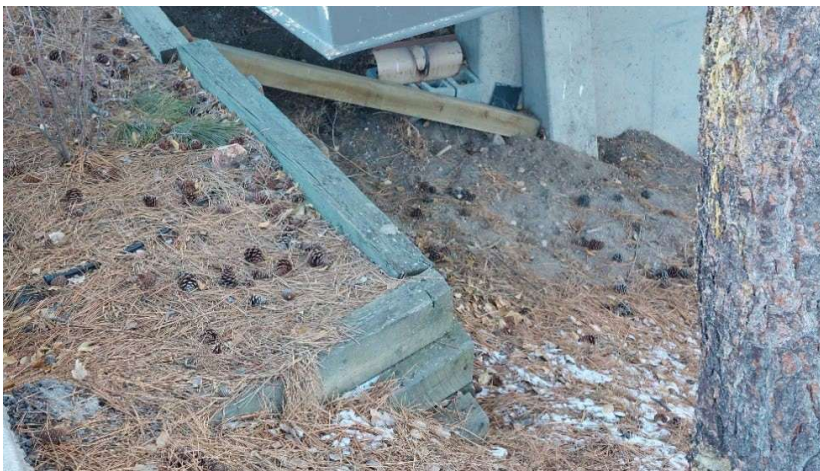
02.03.11 Exterior Walls – Entry Retaining Wall

Description Retaining wall at NE corner of building is made of pressure treated wood. Gradual subsidence of wall has been postponed with wood braces against CU foundation wall, putting force on the wall that it may not have been designed for.

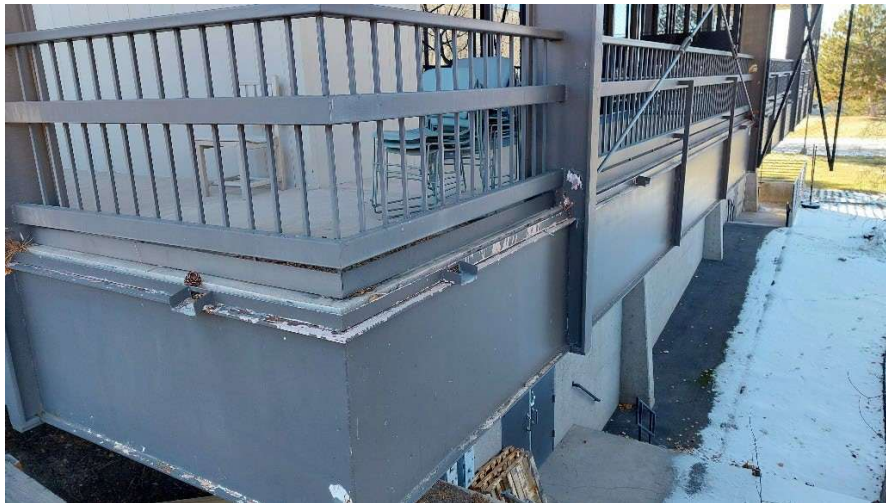
2.03.012 Exterior Walls – Paint on Exposed Structural Steel

Description Paint on exposed structural steel has worn away to expose bare steel.

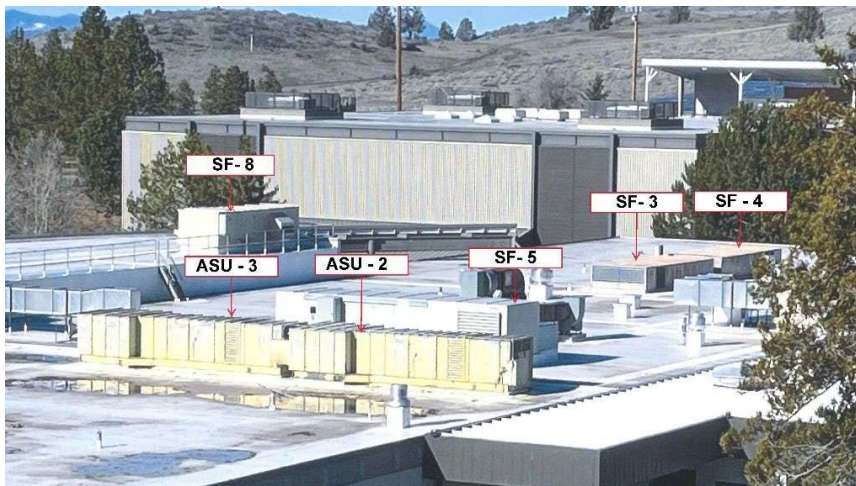
Description Three rooftop air handling units serve the stage areas and other various portions of the building. ASU-2, ASU 3, SF-3 and SF-4 are vintage to the building and SF-5 was added in 1999.

Condition Assessment Equipment is in fair condition.

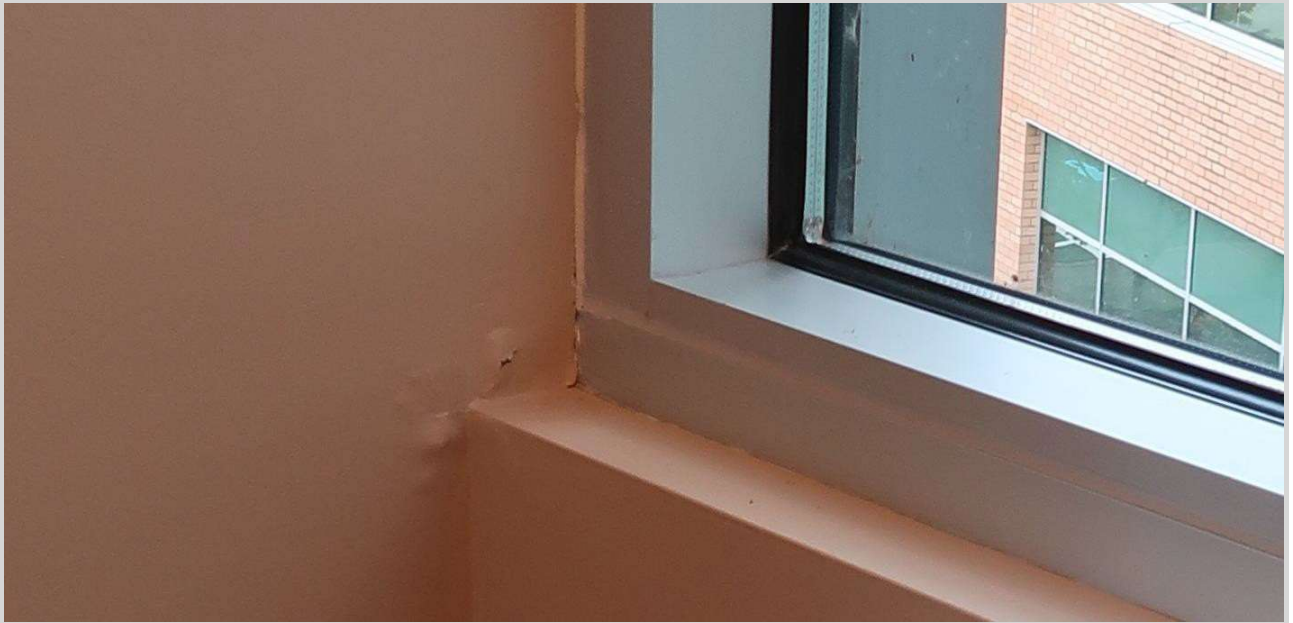
- A-33** Interior: Window sills in some areas will need to have existing sealant replaced after the exterior window work is completed. Windows will shift and create separation at the sills and possible jambs. All windows to be inspected. Construction is not as shown on construction drawings in all parts of the building. There is sealant involved. Once the exterior sill pan work is done it will be more evident as the windows will have moved and sealant opened. See Photo below.

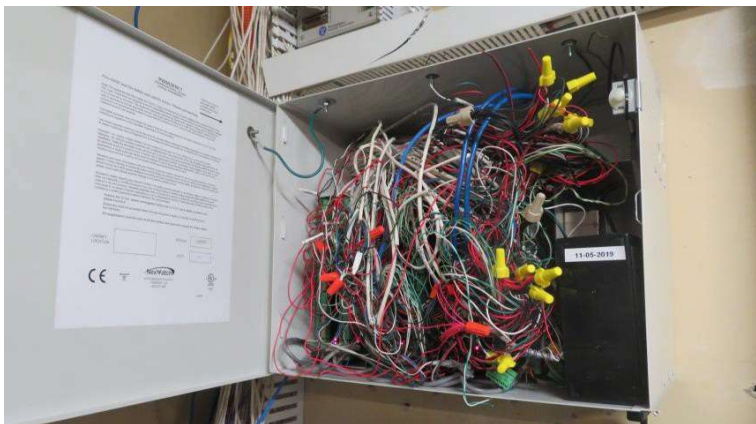
- E-4 Intrusion Detection is not interconnected with Access Control , but is interconnected with the fire alarm system for the fire doors. Remove the intrusion detection system (as a separate system) from the building, including the control wiring, keypads, alarms, and communicators. We also recommend cleaning up wiring. See photo

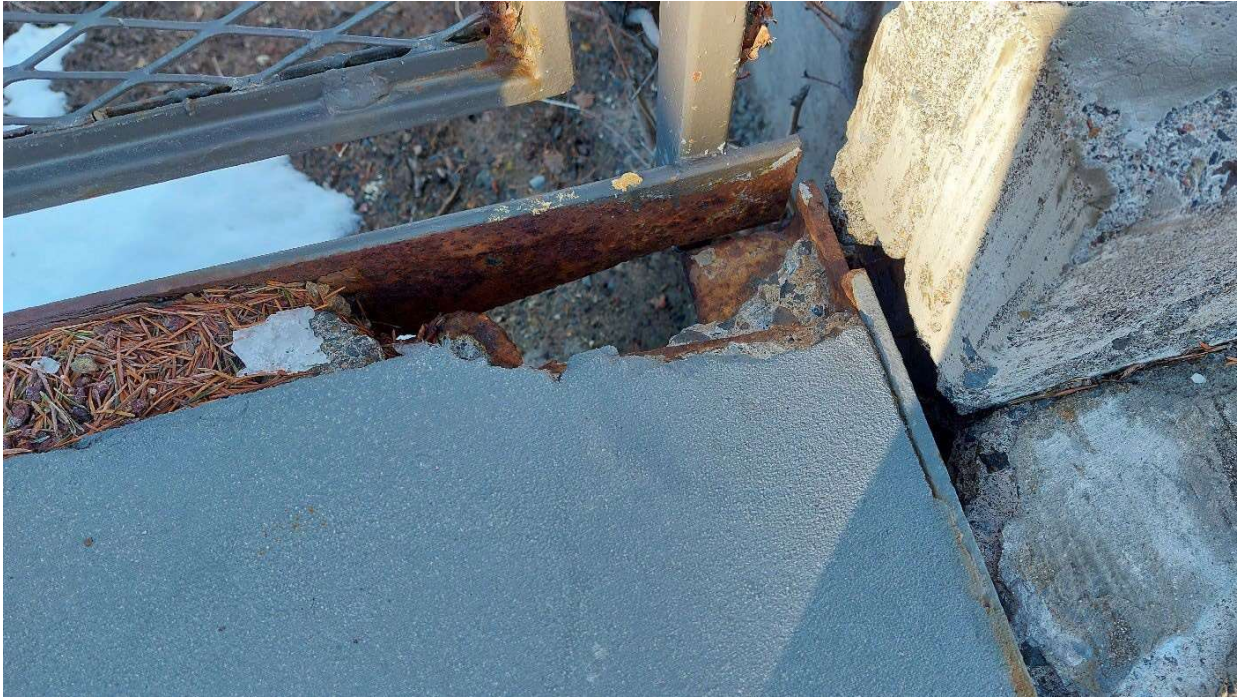
Condition Assessment The bridge, located at the north side of the building, was observed to be exhibiting signs of significant freeze/thaw moisture damage.

Figure 1: Bridge Corrosion at top surface

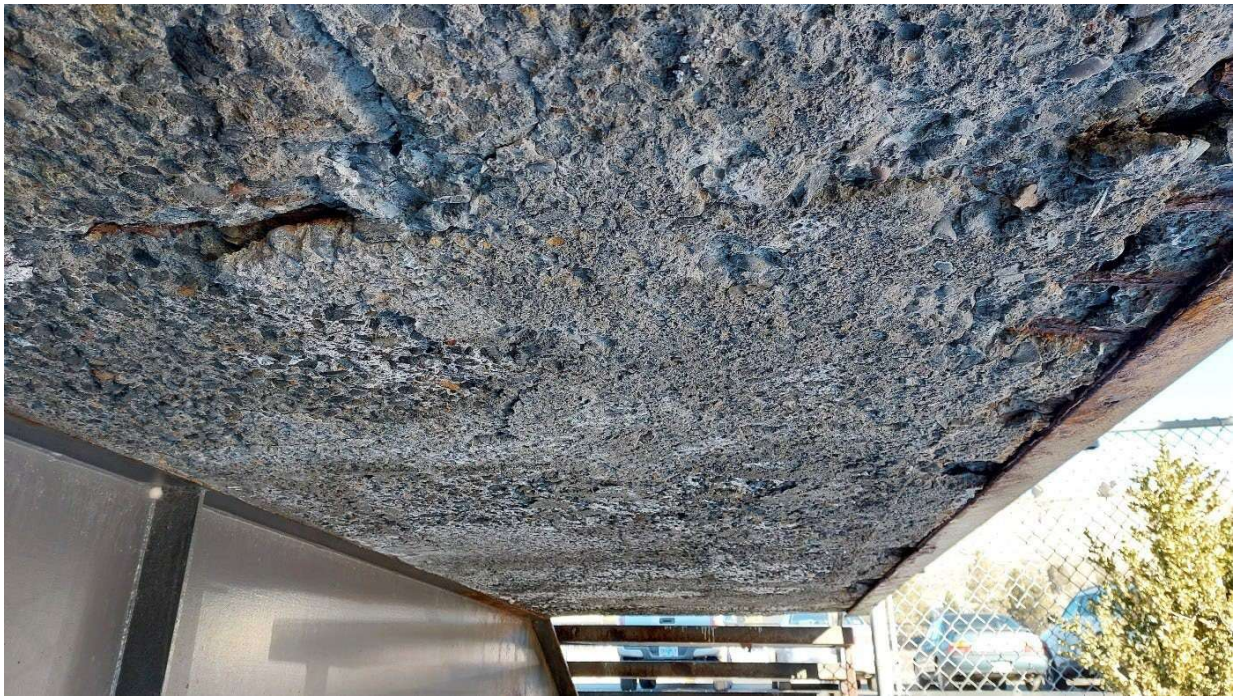
Figure 2: Concrete Deterioration at underside, exposing rebar

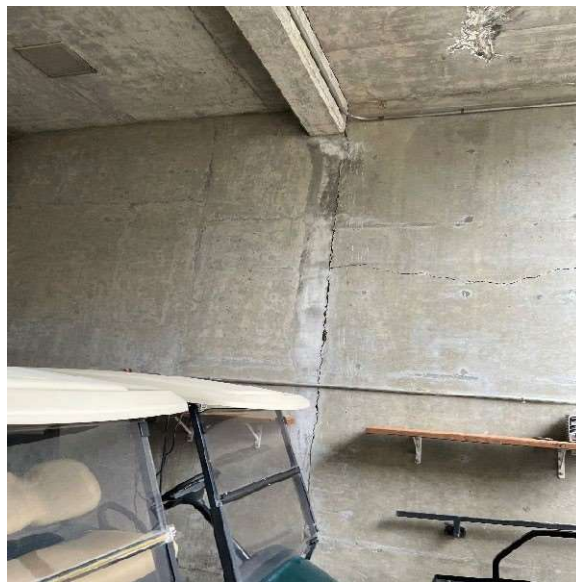
Condition Assessment Vertical and horizontal cracks were observed on the access ramp retaining walls at the west side of the building. Additionally, a small amount of surface moisture damaged was also observed on interior basement walls below glazing units.

Figure 3: Retaining Wall Vertical Crack
