11.0 Appendices

Technical Memorandum

2022 OREGON TECH GEOHERMAL CONDITION ASSESSMENT

Submitted By:
Fluent Engineering, Inc.
June 28, 2022

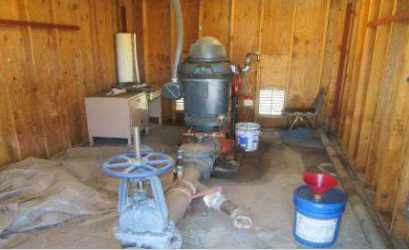
Item #	Location/System Element	Description of Recommended Action	Why is this recommended	Improved Safety	Improves System Resiliency & Redundancy	Increases System Capacity	Reduces System Maintenance Costs	Construction Estimate	Design/Soft Costs	Contingency	Other Costs	TOTAL COSTS	Photos
1	Production and injection wells	Rebuild Well #6: new casing as required, new pump, new or reconditioned pump motor, new wellhouse.	Deterioration of well presents reliability problems, End of life	-	YES	POTENTIALLY	YES	\$ 1,000,000	\$ 200,000	\$ 120,000	\$ 60,000	\$ 1,380,000

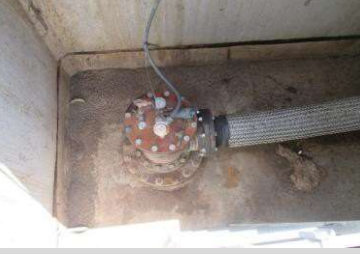
3	Wells	Clean Inj Well #2	Remove scale accumulation in well	-	YES	-	-	\$ 100,000	\$ 20,000	\$ 12,000	\$ 6,000	\$ 138,000

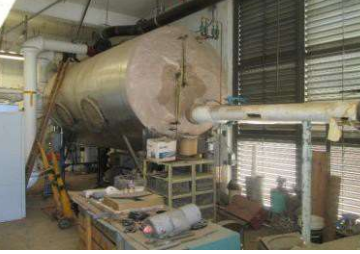
4	Geothermal Mechanical Building	New concrete GEO storage/settling tank, to be located in-ground at about 20' higher elevation.	Existing tank is corroded and at risk of failure. New tank will provide more capacity, more head to better serve campus, better sand removal	YES	YES	YES	YES	\$ 850,000	\$ 170,000	\$ 102,000	\$ 51,000	\$ 1,173,000

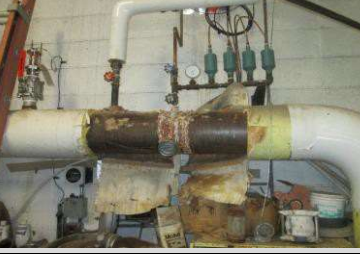
5	Geothermal Mechanical Building	Replace piping and valves inside geothermal building. Accommodate power generation, heat sales to Crystal Terrace, second supply main to campus	Existing piping has been in service for 60 years. Removal of tank will allow reconfiguration of piping	YES	YES	YES	YES	\$ 180,000	\$ 36,000	\$ 21,600	\$ 10,800	\$ 248,000

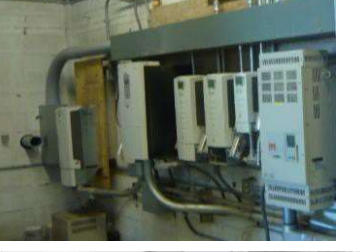
6	Geothermal Mechanical Building	Replace older well pump speed controllers (variable frequency drives) as needed	End of life and reliability	-	YES	YES	YES	\$ 40,000	\$ 8,000	\$ 4,800	\$ 2,400	\$ 55,000

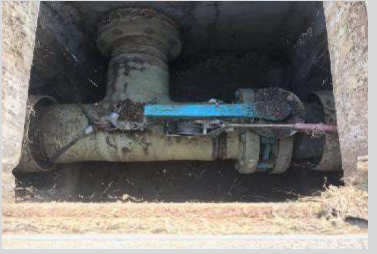
9	GEO Supply Piping	Repair GEO supply piping and valve in the 8" GEO supply pipe vault near Snell Hall	Valve is inoperable, pipe connections are questionable	YES	YES	-	-	\$ 450,000	\$ 90,000	\$ 54,000	\$ 27,000	\$ 621,000

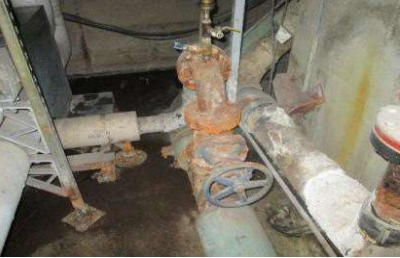
10	GEO Supply Piping	Replace GEO isolation valves in tunnels. Use power operated valves to allow isolation of a leak without entering the tunnel.	Allows work on a segment of the supply system without shutting off entire system.	YES	YES	-	YES	\$ 235,000	\$ 47,000	\$ 28,200	\$ 14,100	\$ 324,000

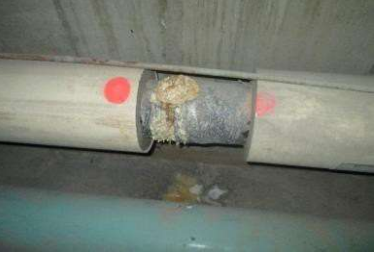
12	GEO Supply Piping	Repair leaks in fiberglass piping joints in tunnels, ~20 places	Improved safety, reduce moisture in tunnels	YES	-	-	YES	\$ 15,000	\$ 3,000	\$ 1,800	\$ 900	\$ 21,000

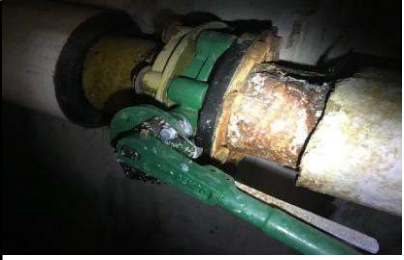
14	GEO Return Piping	Replace about 30' of 6" steel return pipe with FRP pipe and fittings in tunnel where return from residence hall joins return from College Union.	This is the only steel pipe in the tunnel; the rest is FRP. Pipe is corroded, and will continue to be subject to corrosion. Changing to FRP pipe will prevent corrosion and have a longer lifespan.	YES	-	-	-	\$ 30,000	\$ 6,000	\$ 3,600	\$ 1,800	\$ 41,000

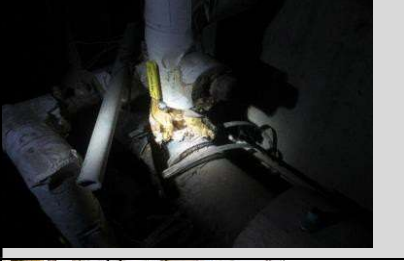
15	GEO Return Piping	Replace building isolation valves	Valves are non-functional. Required to allow working on building piping without shutting off entire system.	YES	-	-	YES	\$ 25,000	\$ 5,000	\$ 3,000	\$ 1,500	\$ 35,000

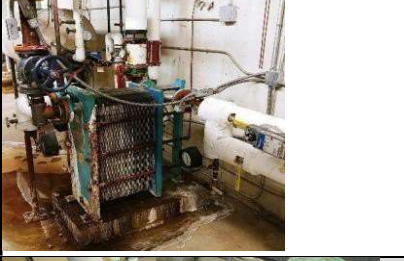
16	Building Heating	Repair or replace leaking heat exchangers in Residence Hall, Learning Resource Center, Facilities, Snell Hall, and Owens Hall buildings. Replace associated GEO piping and valves	Leaking is a safety hazard, introduces moisture in buildings. Leaking heat exchangers prevent operation of power generation because the leakage is worse at lower water temperature.	YES	YES	YES	YES	\$ 350,000	\$ 70,000	\$ 42,000	\$ 21,000	\$ 483,000

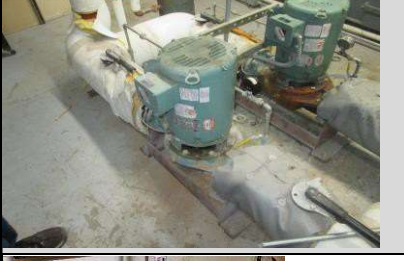
17	Building Heating	Upgrade building heating water equipment and controls to provide variable-flow heating water circulation; with 2-way valves at heating coils, lead-lag variable-speed heating water pumps	Improved reliability and better utilization of available GEO resource, reduced pumping power	YES	YES	YES	YES	\$ 440,000	\$ 88,000	\$ 52,800	\$ 26,400	\$ 607,000

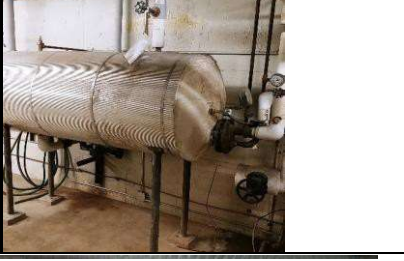
18	Owens Building Domestic Hot Water	Replace domestic hot water heat exchanger and storage tank at Owens	Tank is likely to fail due to corrosion	YES	YES	YES	YES	\$ 45,000	\$ 9,000	\$ 5,400	\$ 2,700	\$ 62,000

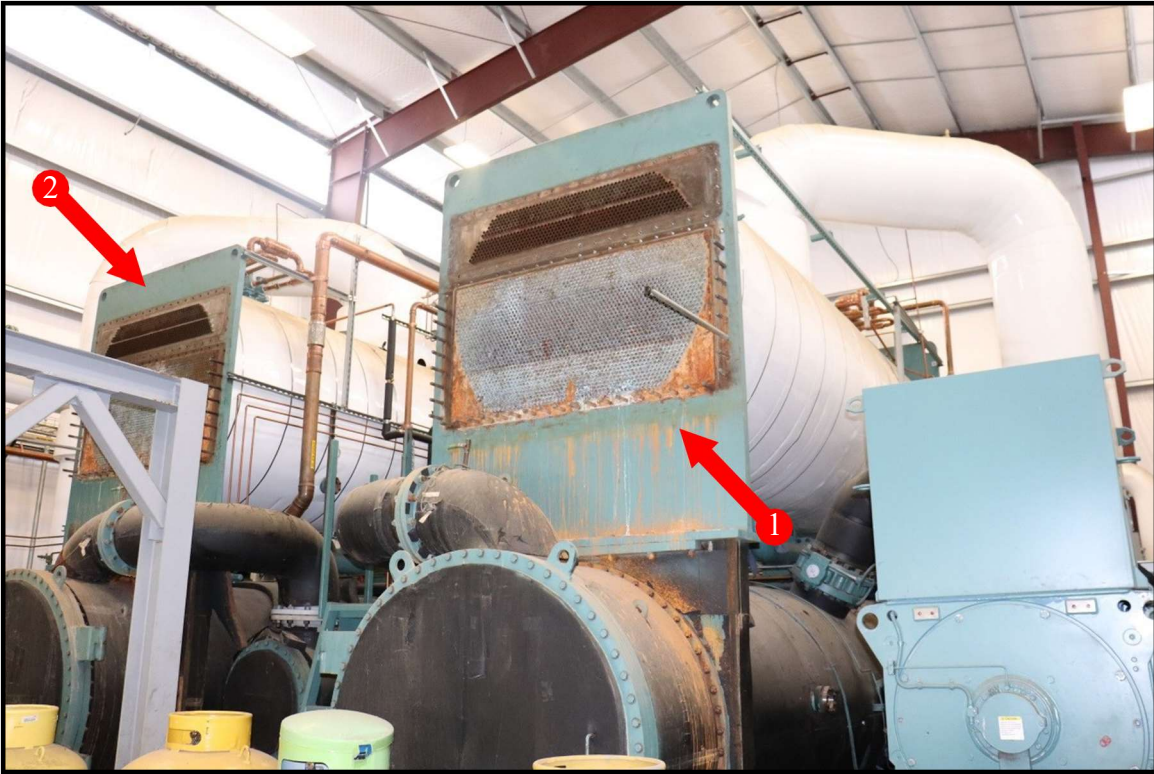
Figure 1 Inside the ORPP building showing partly disassembled system
Arrow 1: Plant A
Arrow 2: Plant B

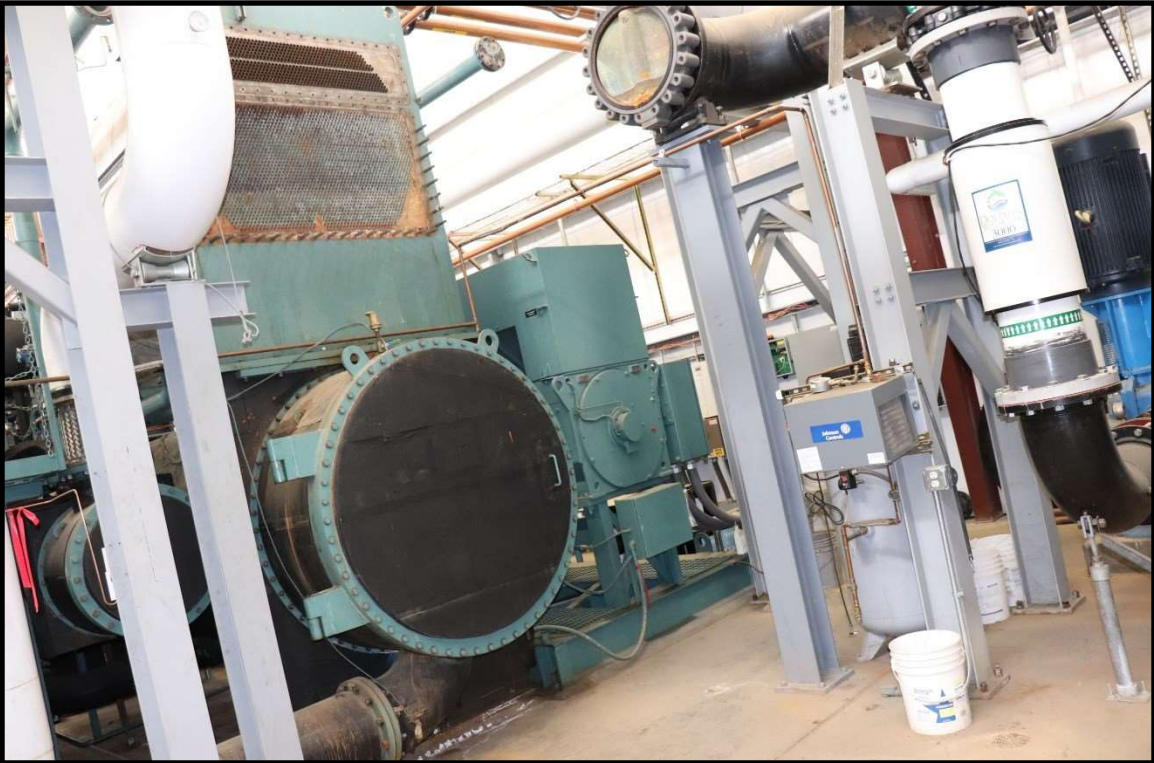
Figure 2 The opposite end as shown in Figure 1 showing partly disassembled system

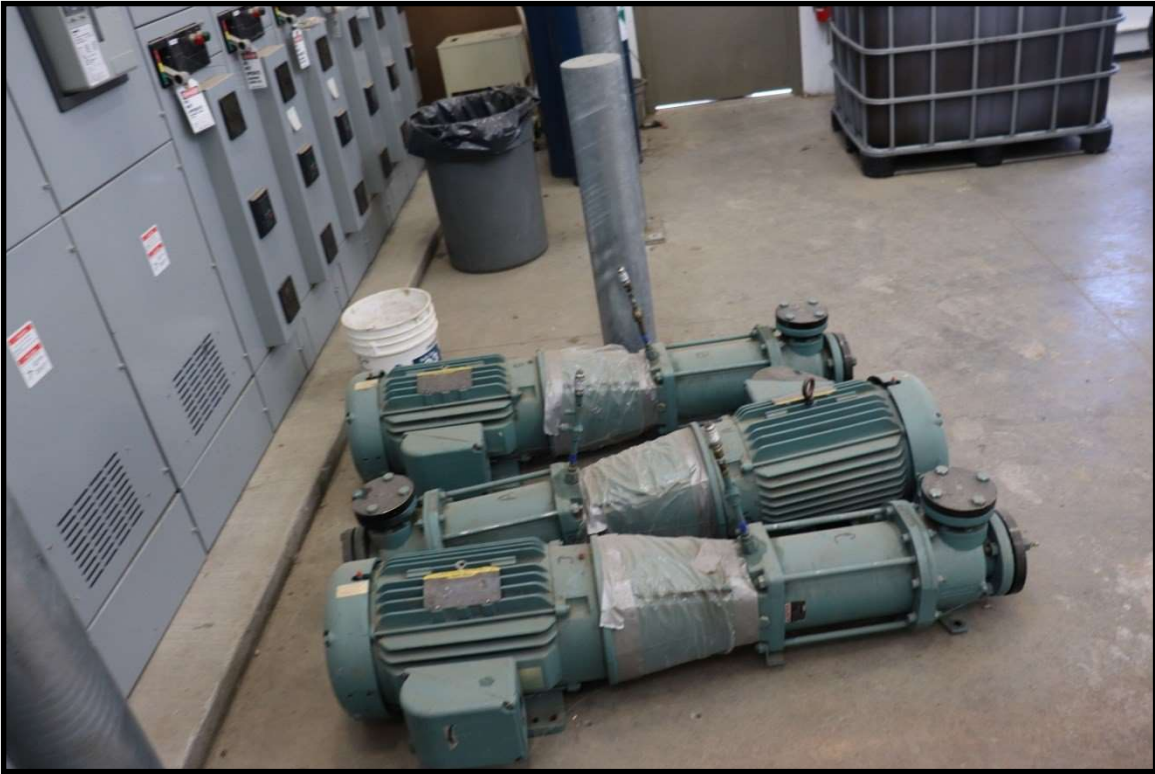
Figure 3 Feed pumps not installed

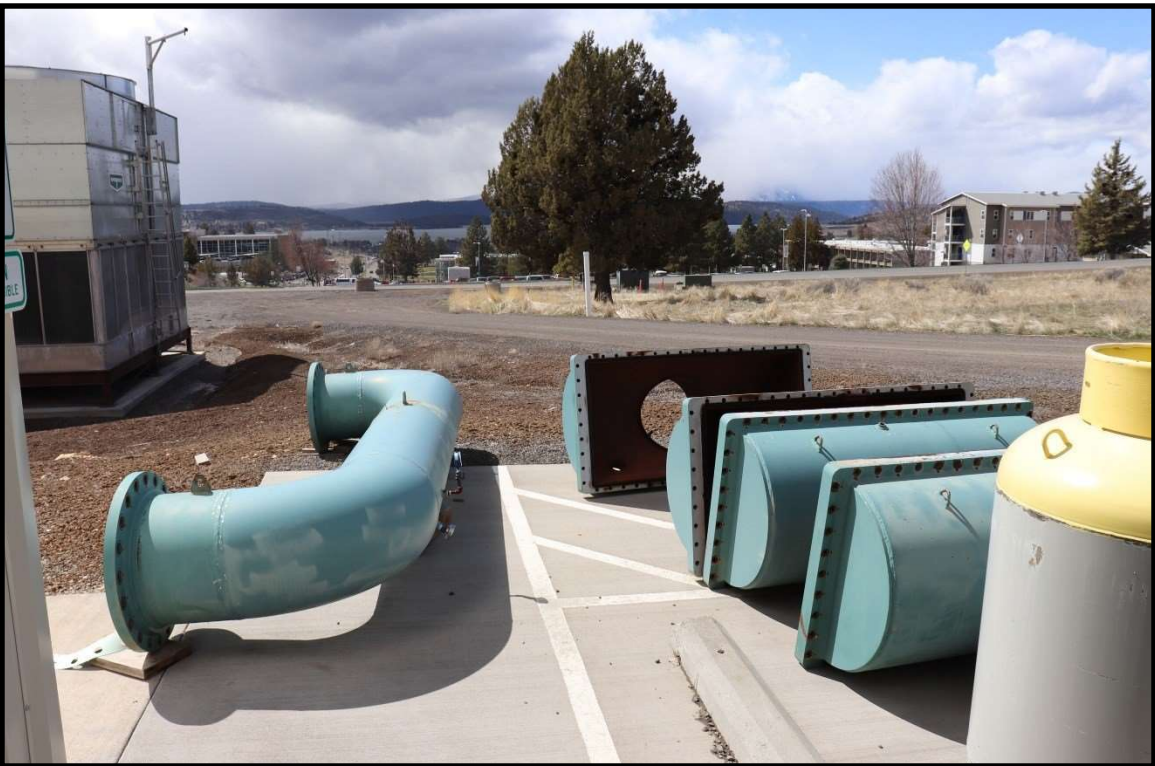
Figure 4 View outside the ORPP building showing covers and piping removed from system

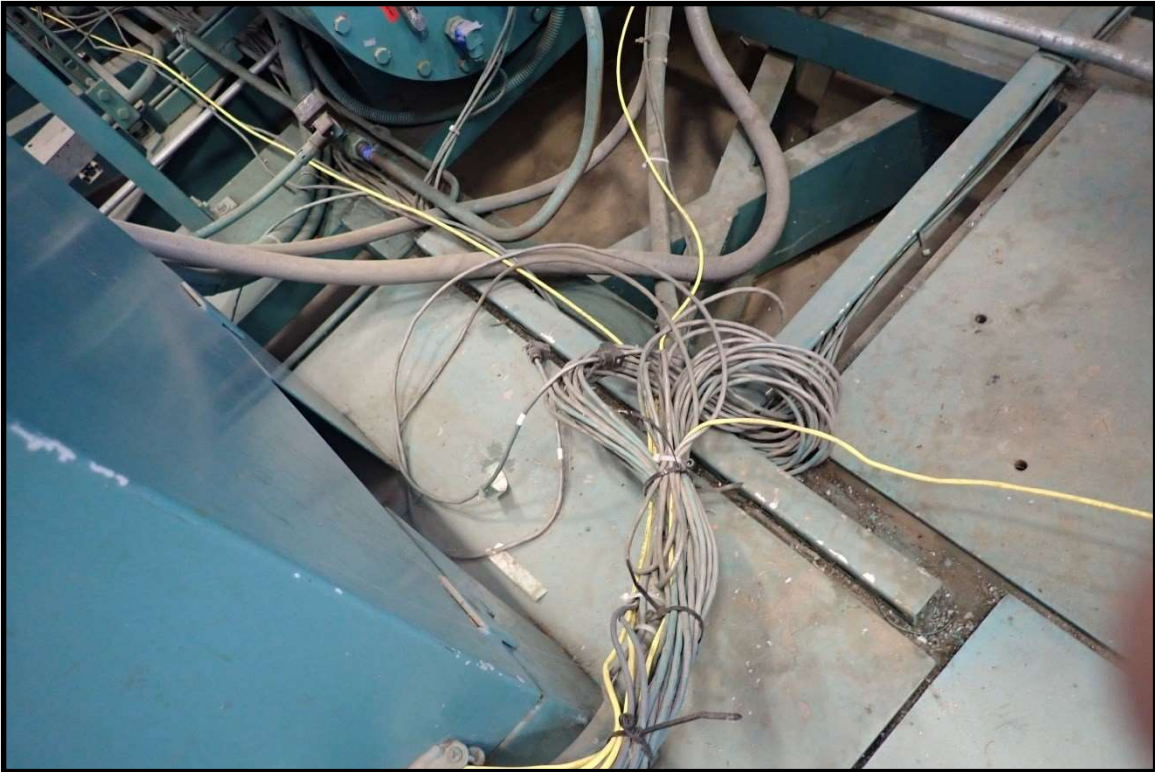
2. Much of the electrical wiring was not routed through conduit and was strewn about in a haphazard manner. There had been several electrical issues and covers for electrical wire trays were removed. Several wires were not connected (Figures 7 – 11).

Figure 7 View of ORPP behind a control cabinet showing wires not in conduit and strewn about haphazardly

In summary, the ORPP does have the capability of power generation as quoted by JCI albeit at a slightly reduced amount should some unknowns regarding the feed pumps require it. The physical limitations of the ORPP such as leaks and wiring issues can be corrected with typical methods. The make-up water from well 4 can be used, provided the pulse wave devices are properly energized.

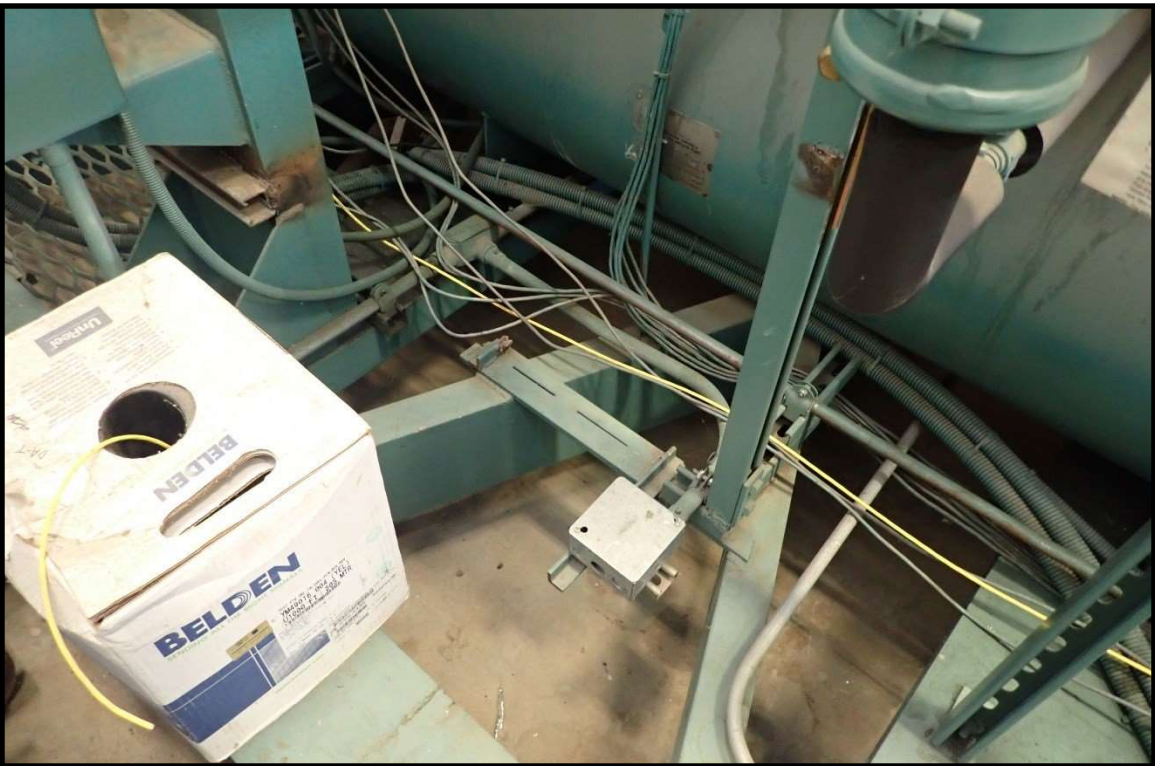
Figure 8 Alternate view of ORPP showing wires not in conduit and strewn about haphazardly

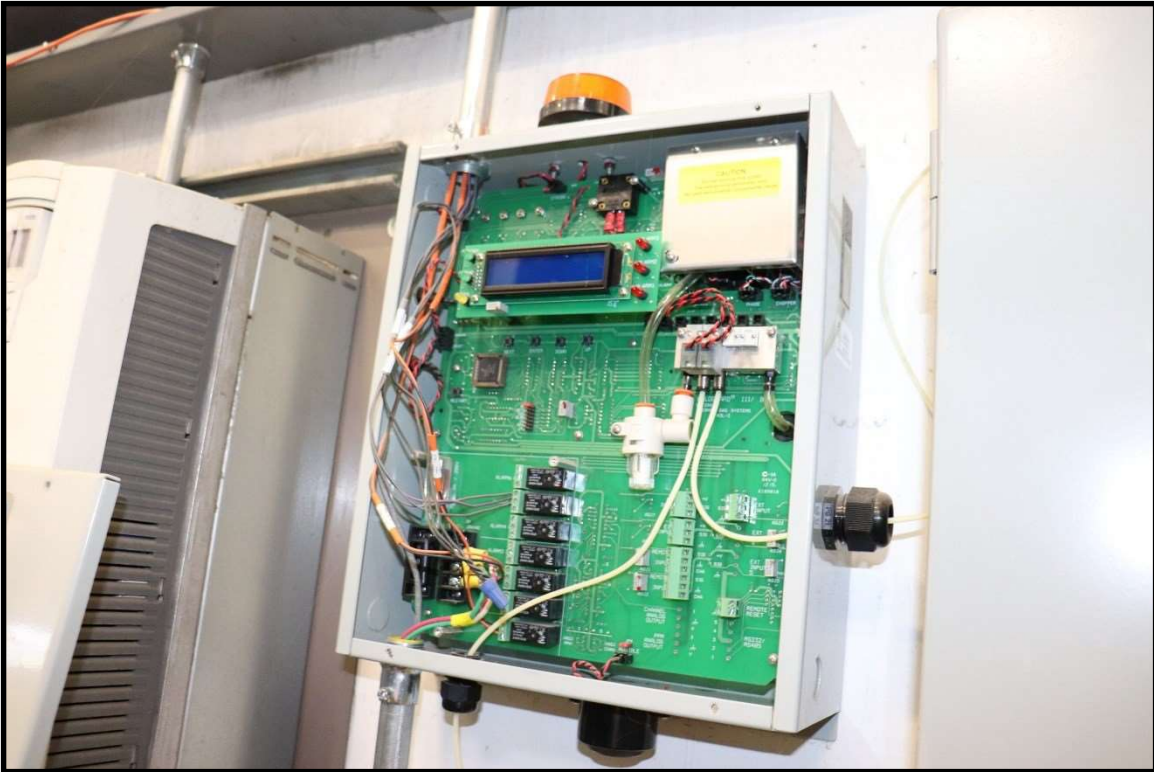
Figure 9 Control box with cover removed

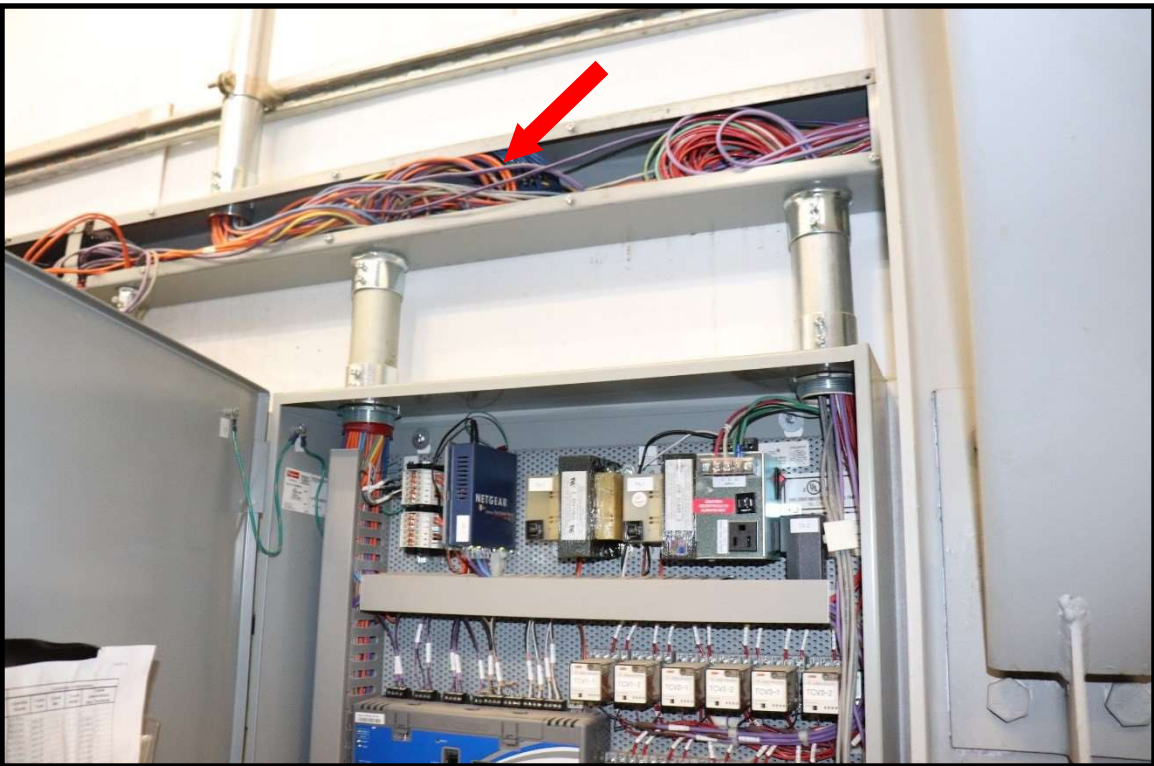
Figure 10 Another control box with door open, arrow points to wireway with cover removed and wires pulled out

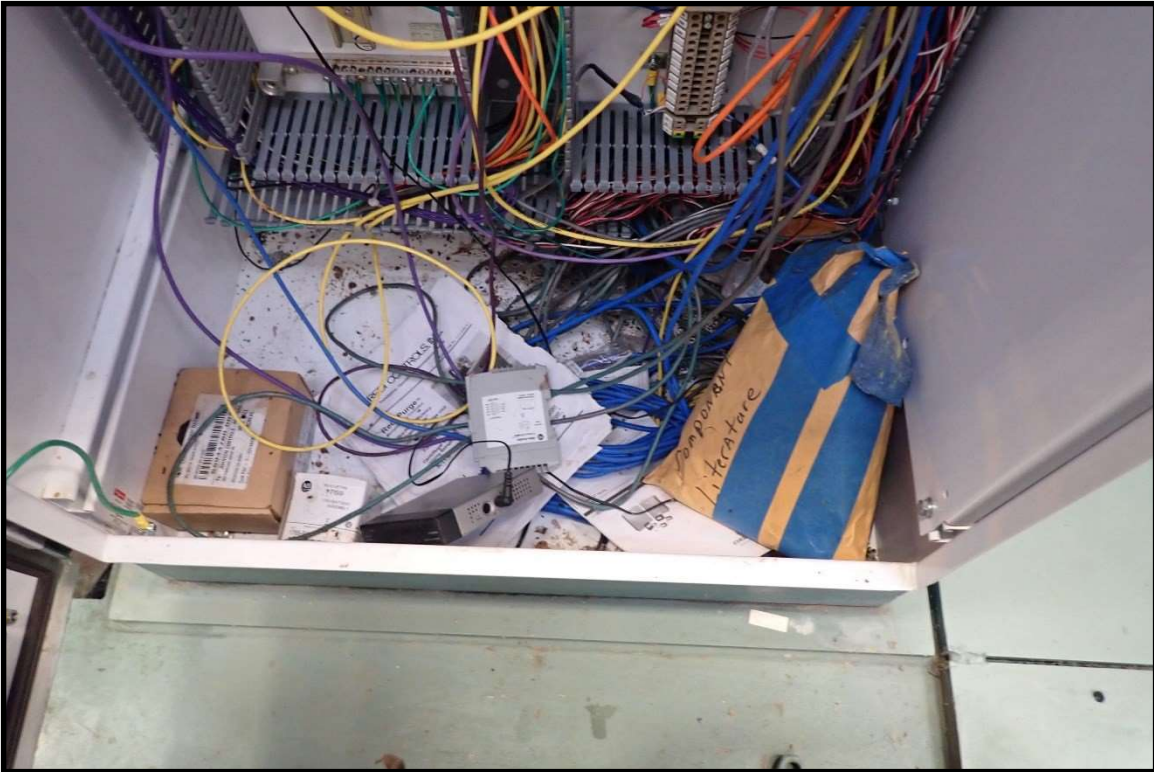
Figure 11 Wires inside a control cabinet not restrained in wireways, wires and debris in bottom

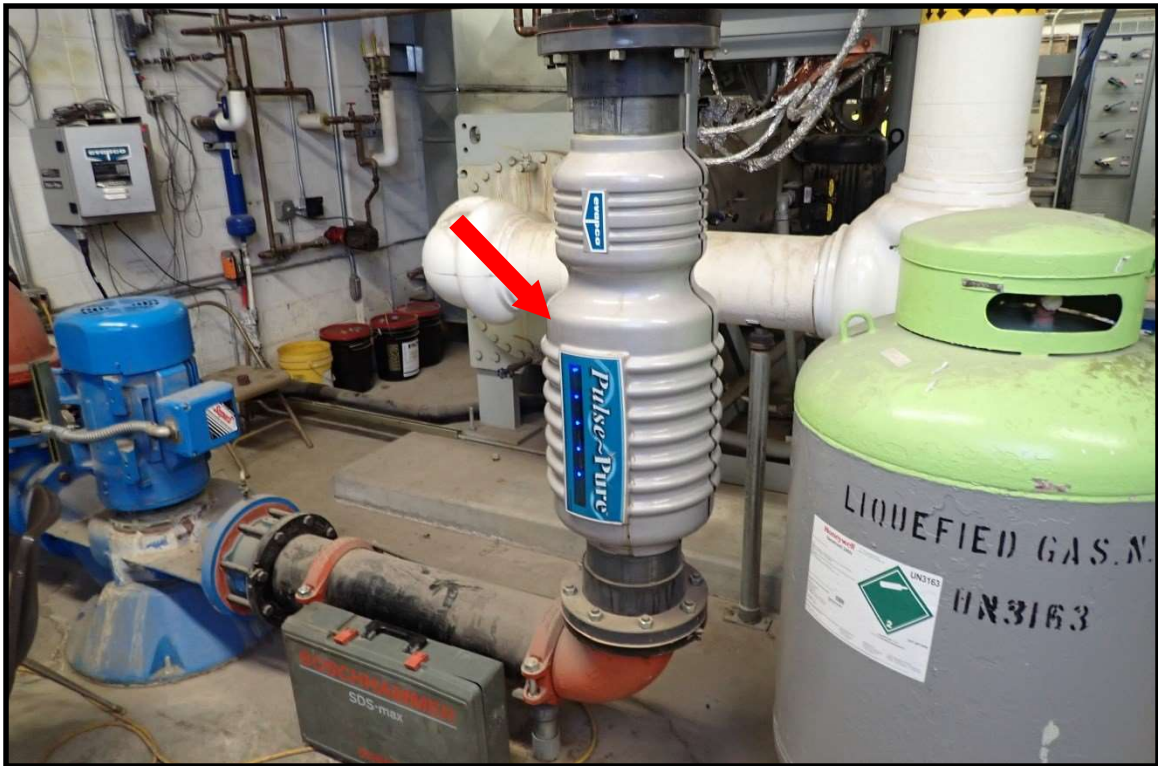
3. Water from well 7 was being used in another ORC plant (plant C). Plant C is shown to be capable of generating 225 kW of electrical power. Plant C is fitted with an Evapco Pulse-Pure pulse wave water treatment device (Figures 12 – 14).

Figure 12 View inside plant C building, arrow points to the pulse wave water treatment device from Evapco

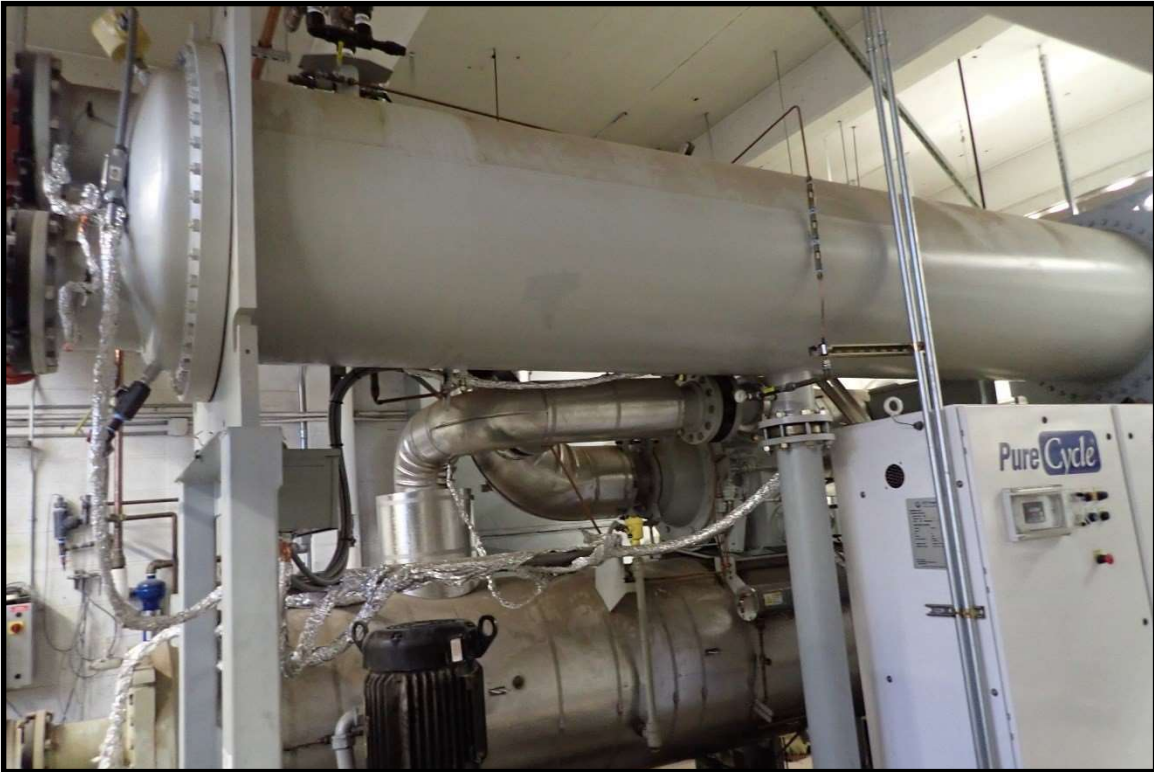
Figure 13 Alternate view of plant C

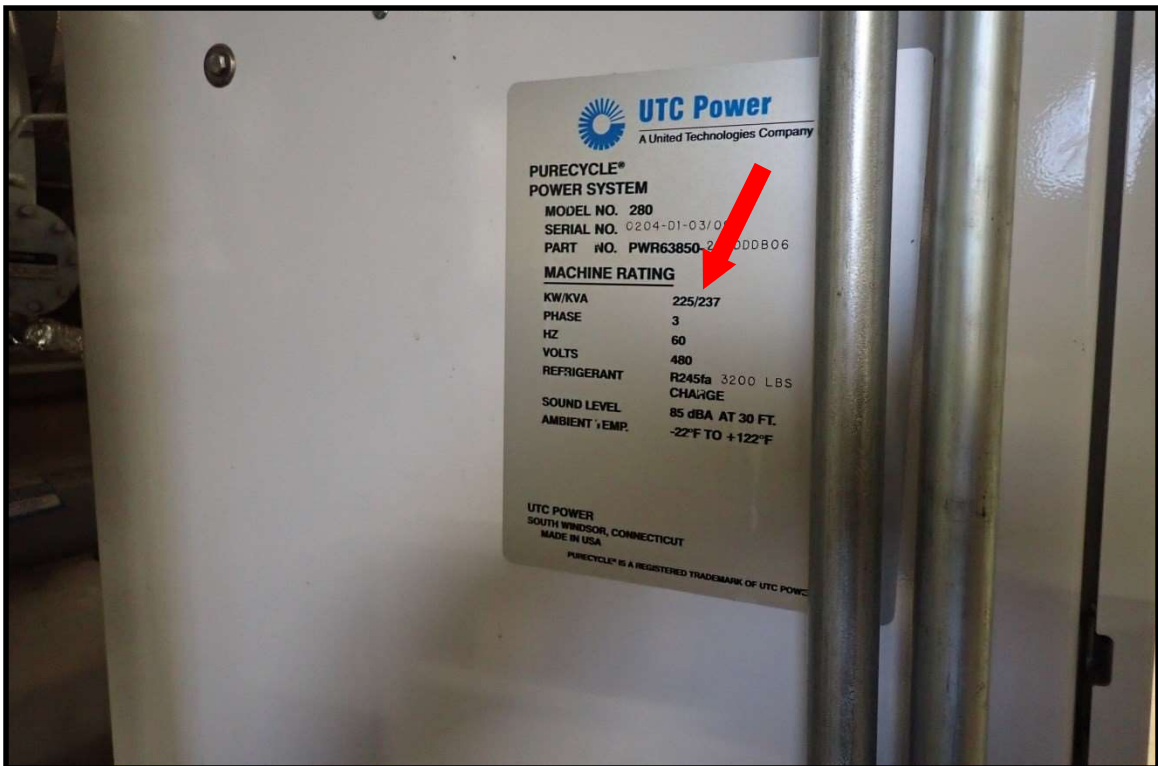
Figure 14 Plant C label plate, arrow points to rating of 225 kW

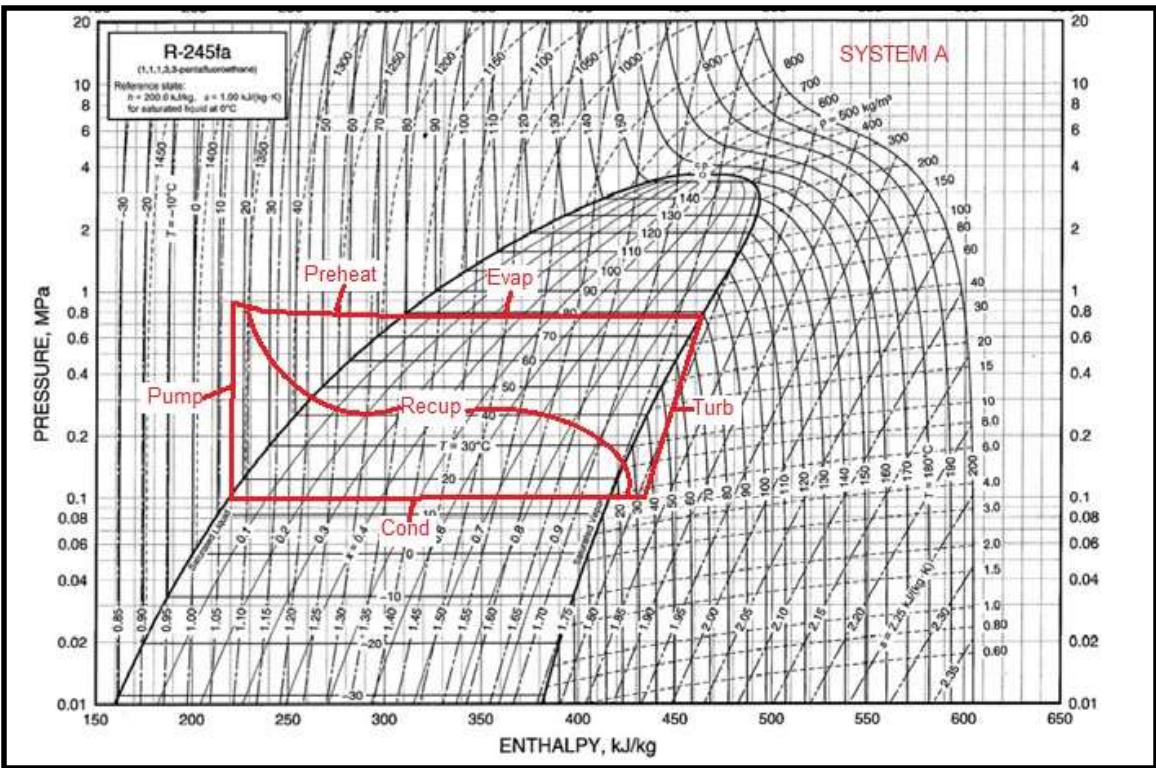
5. The design flow rates, temperatures, and pressures of all fluids were used in generating baseline mathematical models of plants A and B modelled as a single unit for simplicity (Figures 16 – 18).

Figure 16 Pressure enthalpy diagram of plant A

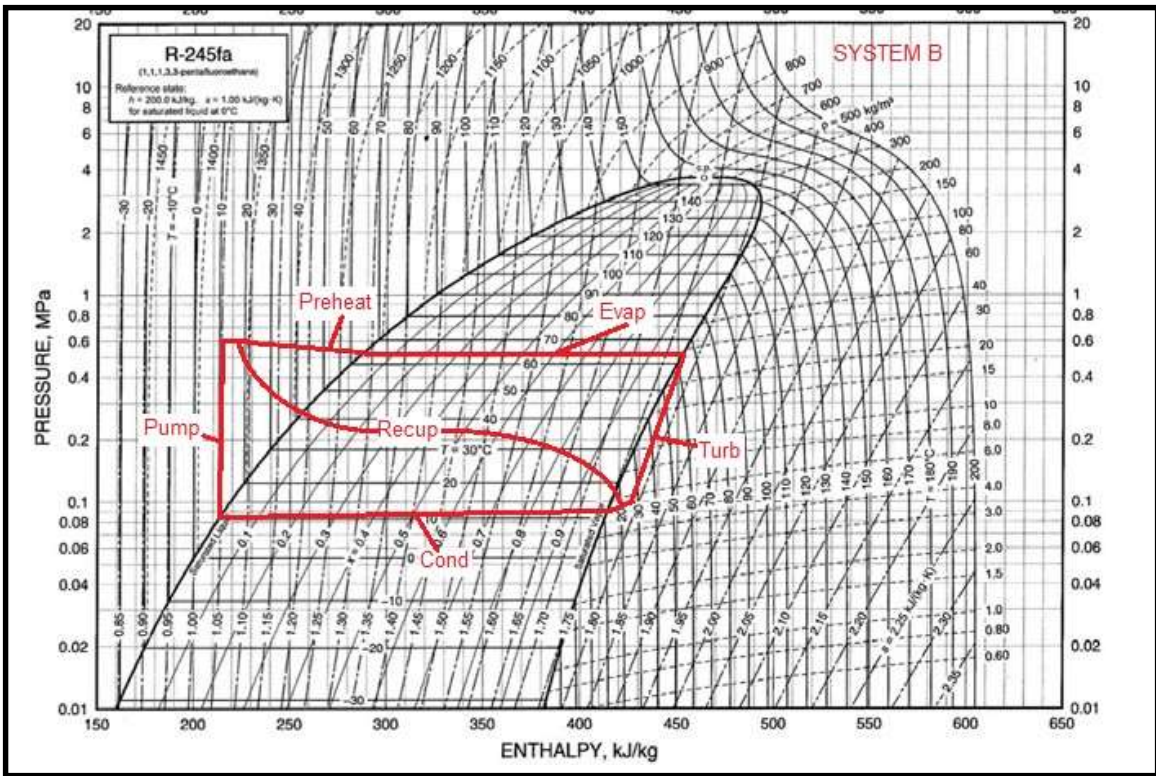
The ORPP is capable of generating power levels as described by JCI. JCI needs to provide a plan for reassembly, leak checks, functional testing of the generators and turbines, and establishment of operational parameters that yield the most robust operating envelope. This robust operating envelope may be outside the most efficient at which the ORPP is capable, which may mean a net output loss. Additional maintenance and operational changes may be acceptable if they resulted in a net decrease of less than 10%. An example of operational changes is related to the feed pumps. The lower pressure of plant B results in an increased risk of cavitation in the feed

Figure 17 Pressure enthalpy diagram of plant B (note “Cond” line is lower pressure than in plant A shown in Figure 16)

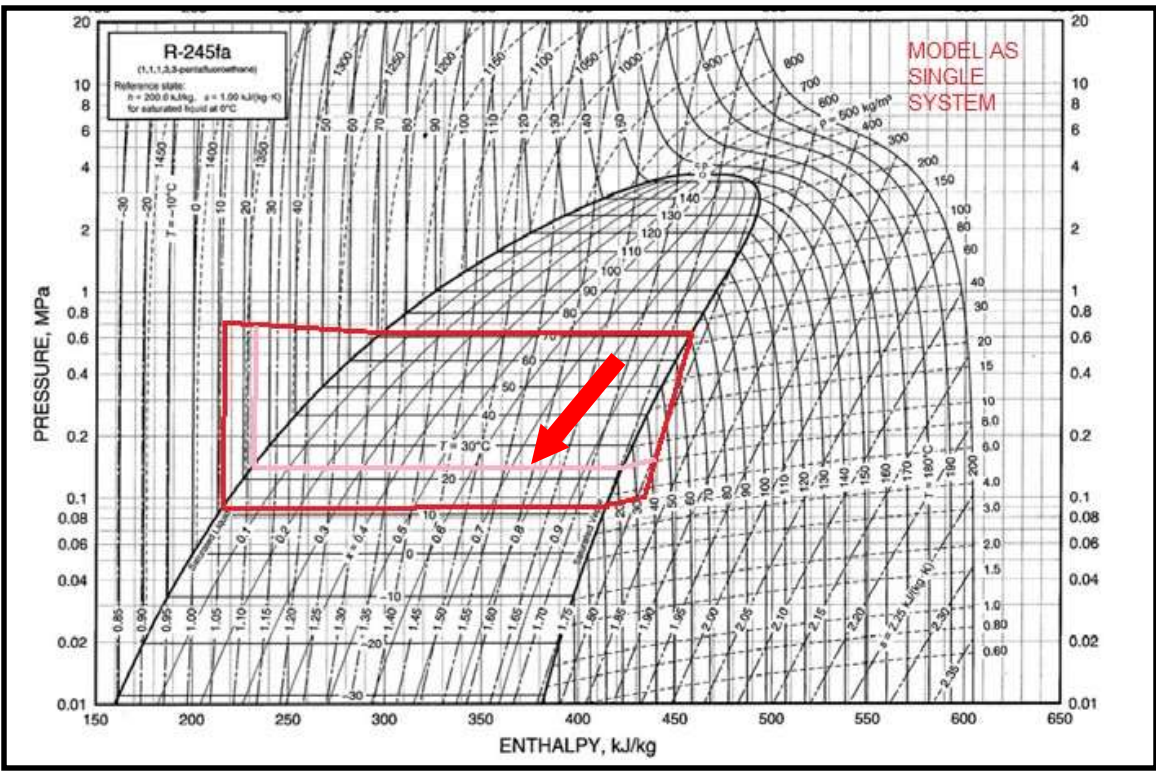
Figure 18 Light colored line represents operating points when the outside temperature is at its highest (arrow)

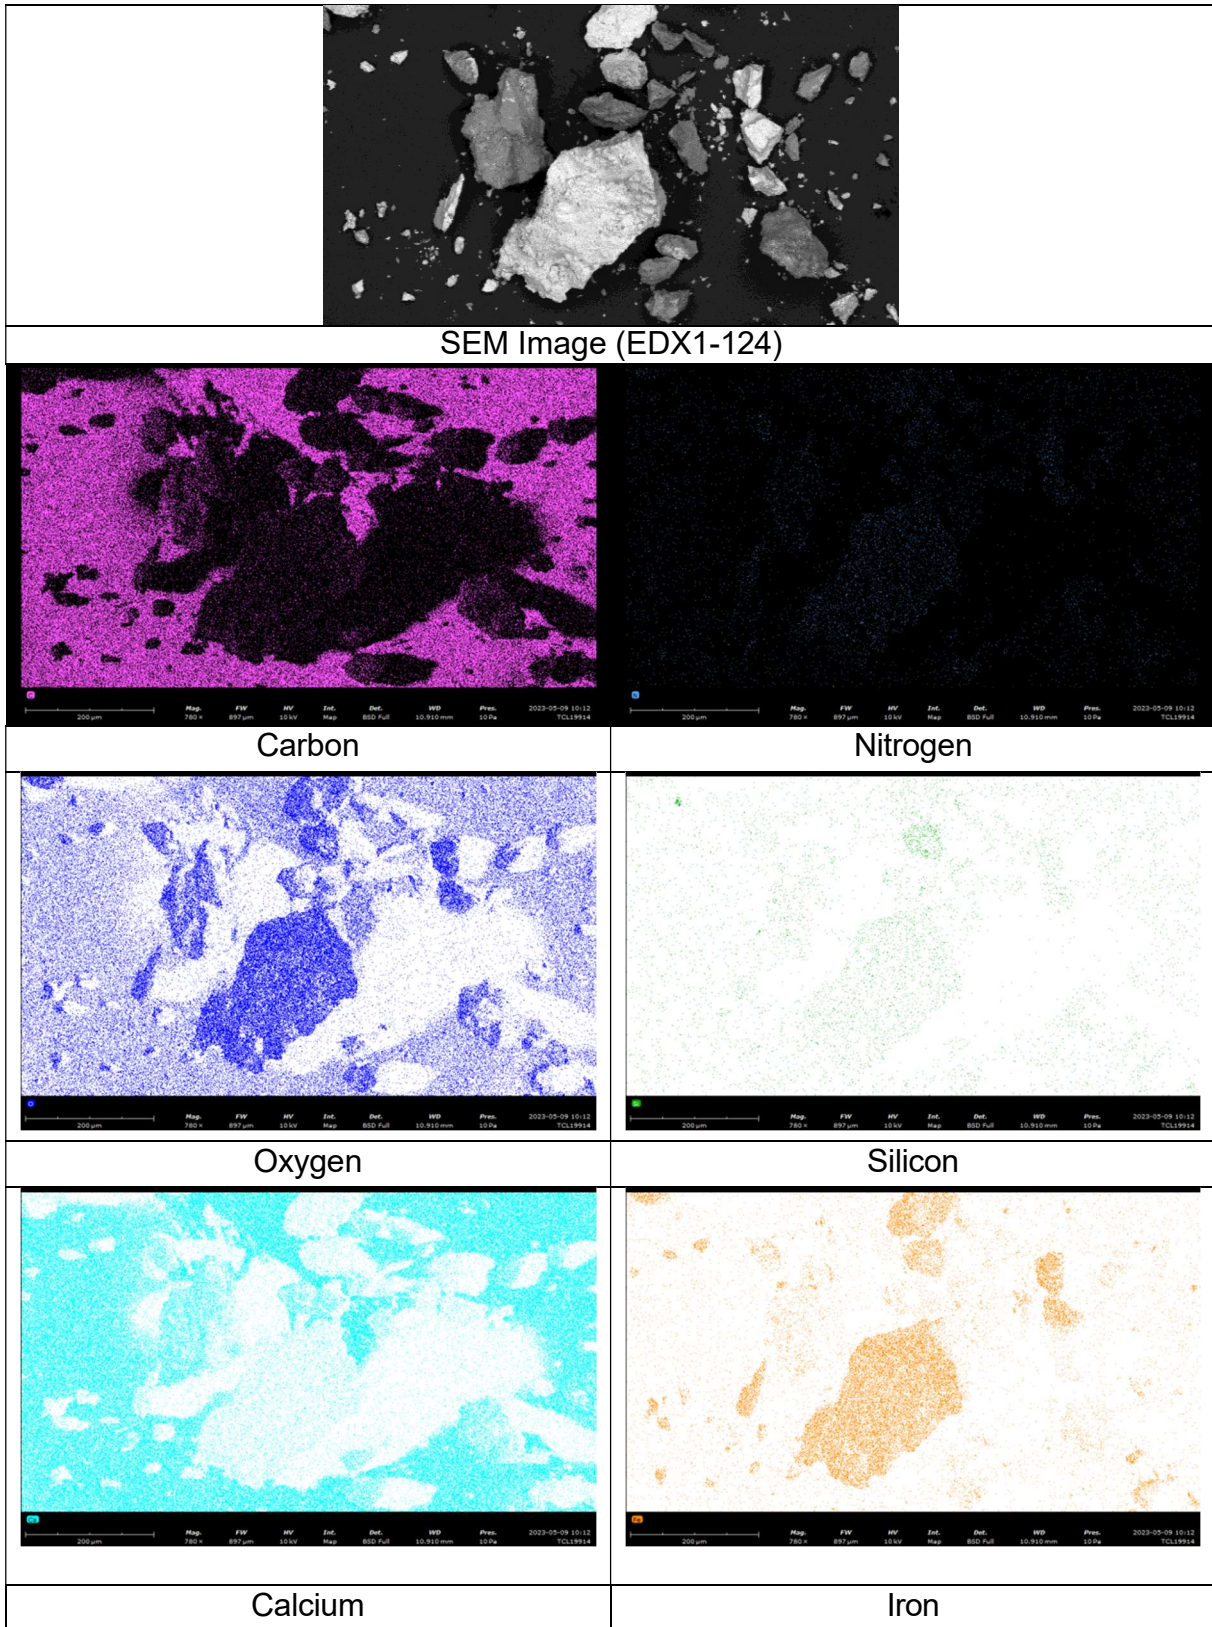
6. Samples of material removed from blocked heat exchangers were sent to Triclinic Labs of Lafayette, Indiana. The SEM and EDX-STD tests showed the material that had deposited as scale was consistent with calcium carbonate (limestone). The silicon content of the first material was 0.2% by weight. The second sample that had been a loose accumulation similar to a rock was consistent with calcium carbonate and oxidized iron. The silicon concentration of the second sample was 1% by weight Appendix II.

Figure 1. SEM image and EDX elemental color maps of Foreign material 1.

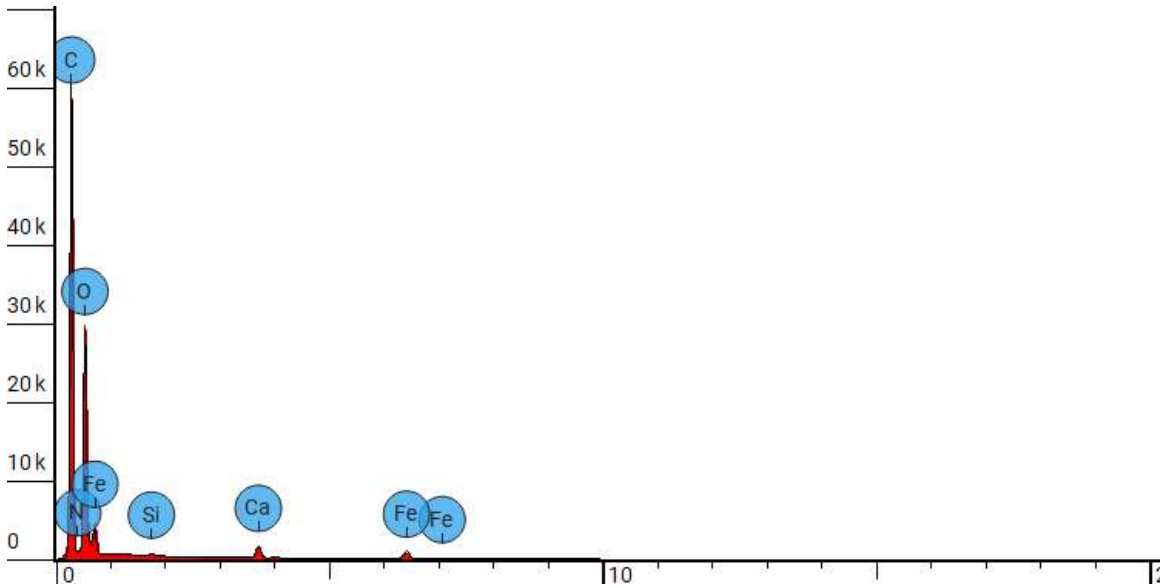
Figure 2. Composite EDX spectrum and elemental composition for Foreign material 1.

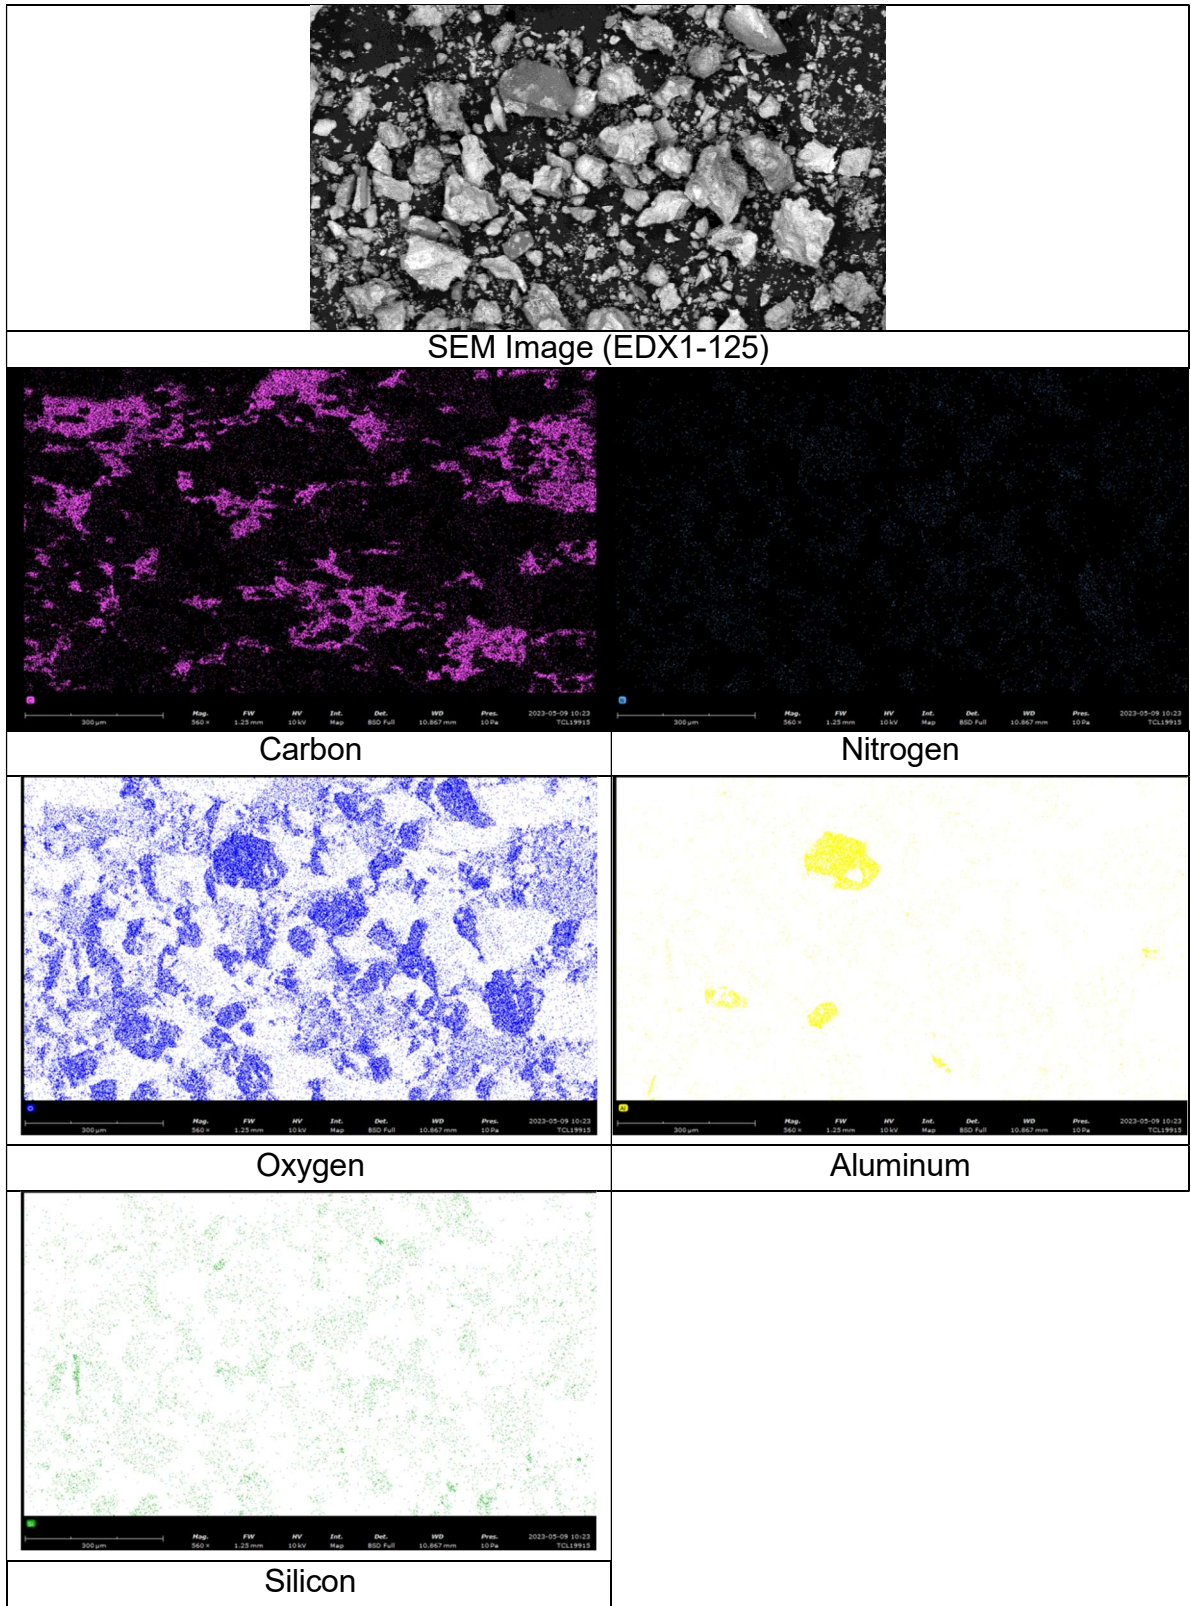
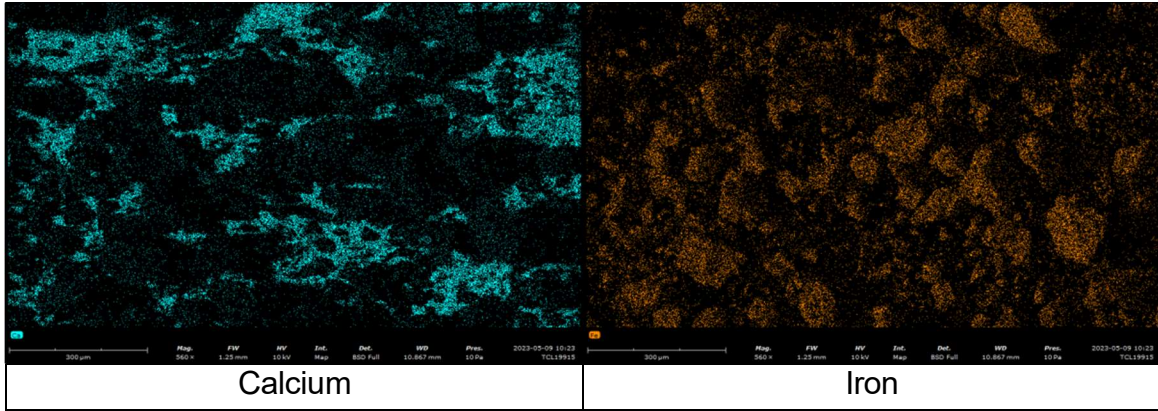
Figure 3. SEM image and EDX elemental color maps of Foreign material 2.

Figure 3 cont. SEM image and EDX elemental color maps of Foreign material 2.

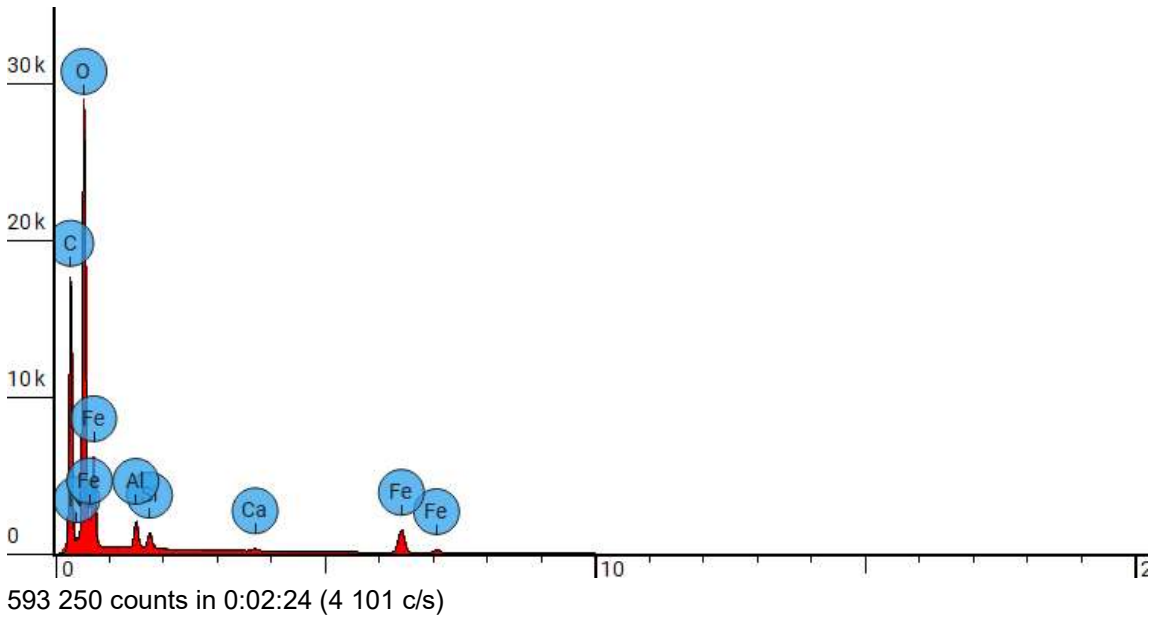
Figure 4. Composite EDX spectrum and elemental composition for Foreign material 2.

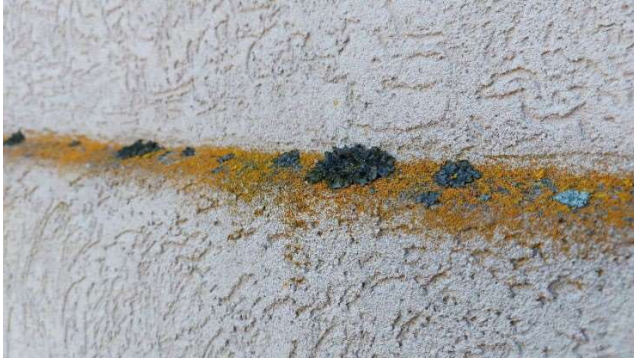
Description The Exterior Insulation and Finish System is generally in good condition except that a number of the reveals in the system have accumulated lichens on the north and east sides of the building. Also, sealant between the EIFS panels is separating from the EIFS. This will lead to leaks if it hasn't already.

Condition Assessment Fair. All joints in the EIFS panels should be resealed. The surfaces of the reveals should be cleaned to remove lichens, with a solution recommended by EIFS manufacturers.
