11.0 Appendices

Technical Memorandum

2022 OREGON TECH GEOHERMAL CONDITION ASSESSMENT

Submitted By:
Fluent Engineering, Inc.
June 28, 2022

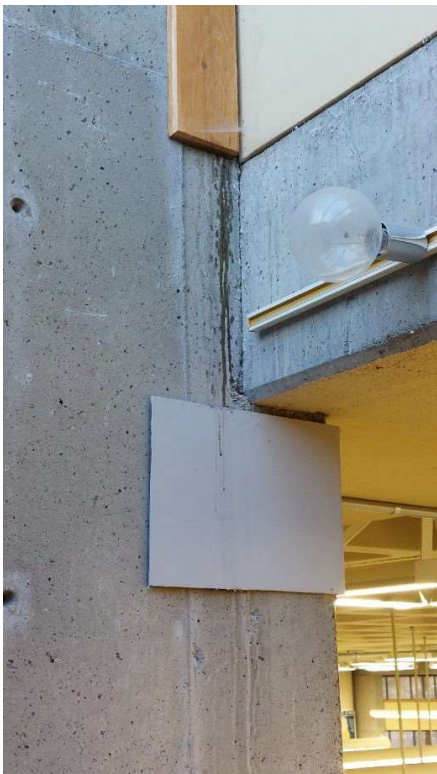
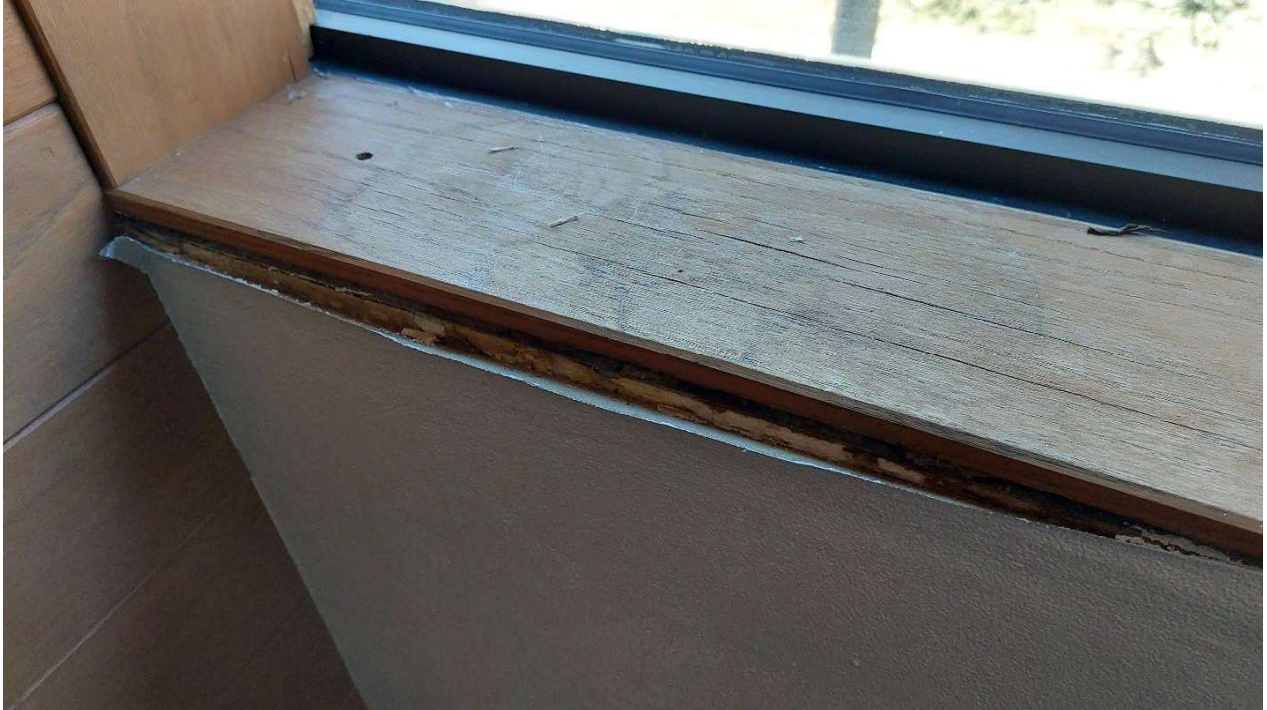
Condition Assessment Fair. Several locations of intermittent leaks were observed.

Event Justification & Strategy: Windows need to be water tested to identify leaking locations, and repairs need to be made at those locations. In some places, repairs are also needed to finishes which have already been water damaged.

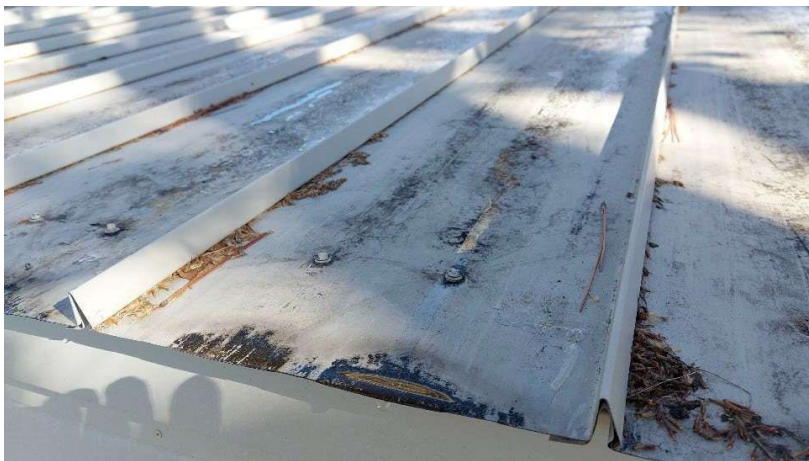
Description A single ply .60 mil TPO roof was installed over the majority of the roof in 2014. This should not need replacement until 2037. The lower standing seam metal roofs, however, are in need of replacement. The roof finish is wearing away, indicating that it was probably a less expensive silicon polyester finish rather than a PVDF finish. Snow and leaves accumulate at the eave, contributing to standing water or moisture for long periods.

Condition Assessment Poor. The metal roofing is rusting and will leak. Rather than replace the roofing, as part of the planned renovation, the altered areas should be restored to their original condition. The skylights should be tested for watertightness and repaired if needed. The built in planters should have the interior resloped to drains with lightweight concrete and coated with waterproofing and with some form of vegetation restored. The techniques of green or vegetated roofing have advanced since the original design of the building and have also advanced since these alterations were made.

Event Justification & Strategy: The roofing needs replacement to prevent leaks. The building should be restored to its original or near original condition.

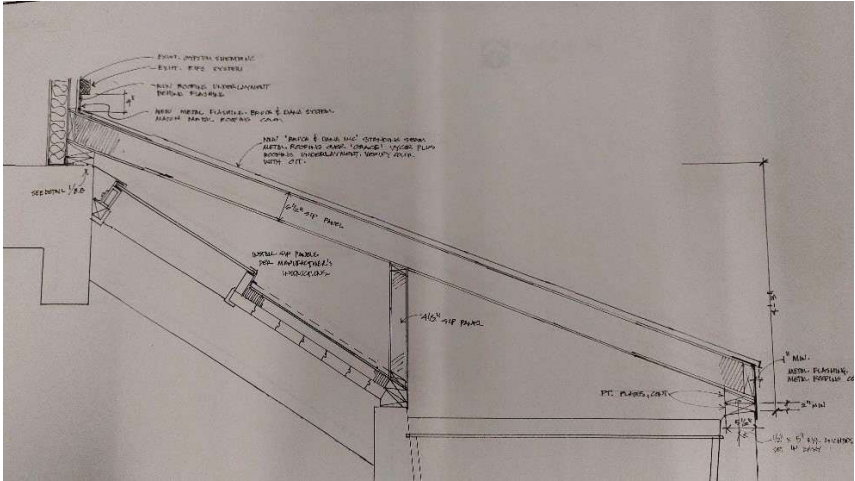
This roofing was installed at some point on wood framing to cover up the skylights, existing metal roofing and built in concrete planters as shown in the drawings below.

Its not clear why this was done. The structural insulated panels (SIP on the drawing) add insulation, and perhaps the skylights were leaking. This alteration significantly changed the appearance of the building from the original design.

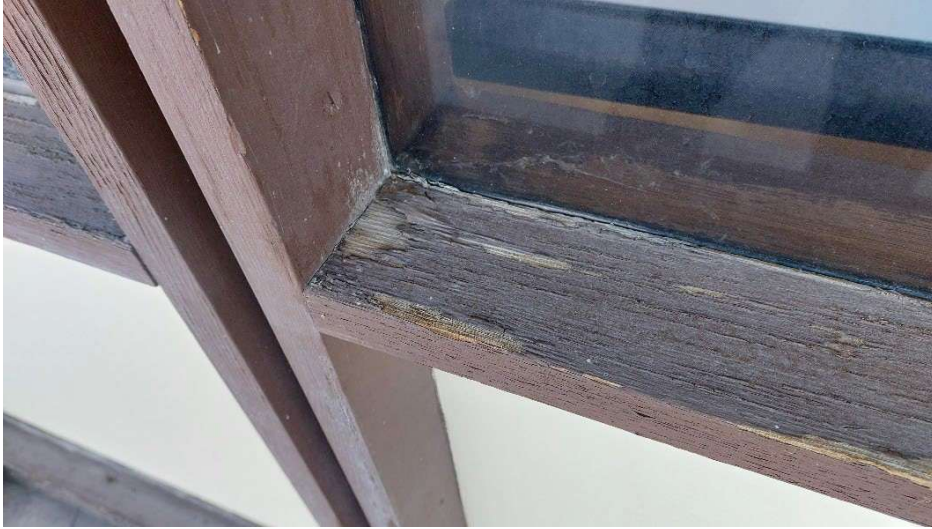
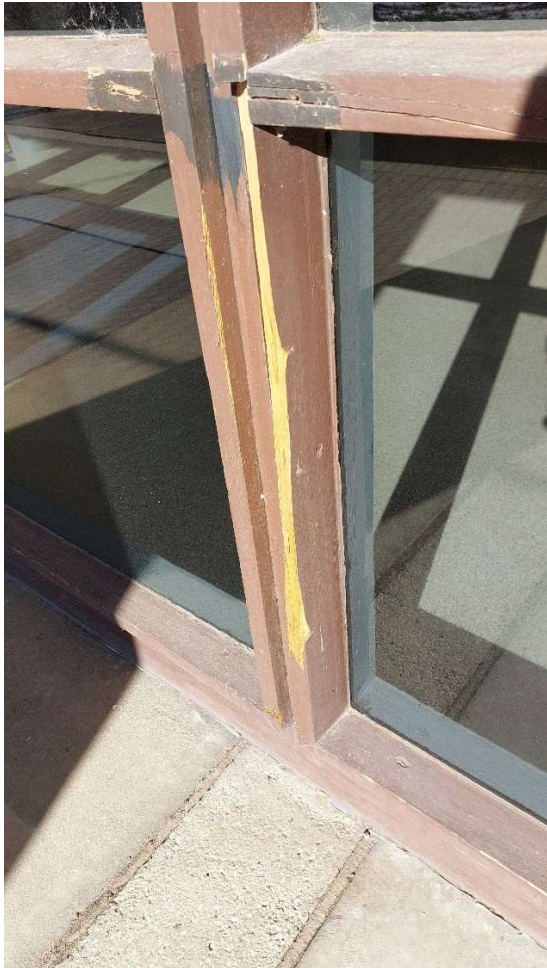
02.03.040 Exterior Windows

Description The windows are wood framed and site built with single pane glass. They don't appear to have ever been repainted. Deterioration of the 60 year old painted wood is evident in a number of places.

Condition Assessment Fair, poor at select locations.

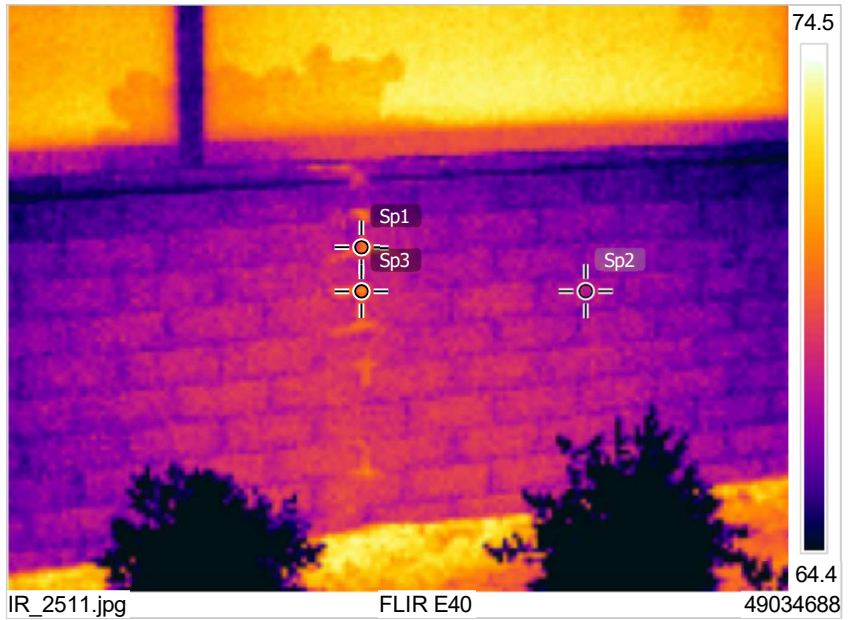
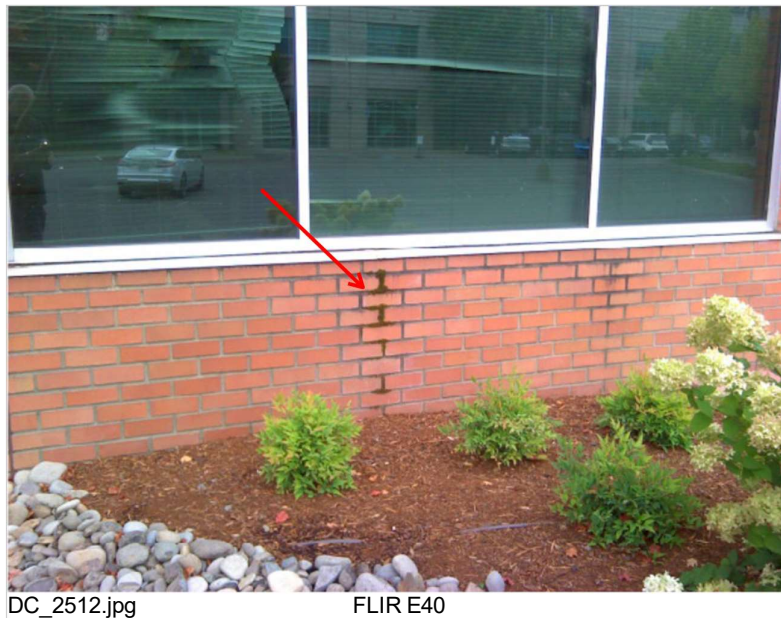
Brick Veneer

This image shows moisture in the brick veneer. Spot Tool 1 and 3 indicate moisture retention where moss is growing. Spot Tool 2 shows the ambient wall temperature. This condition occurs in numerous locations.

Sp1	84.1
Sp2	72.5
Sp3	75.8

Refer to architect report for remediation

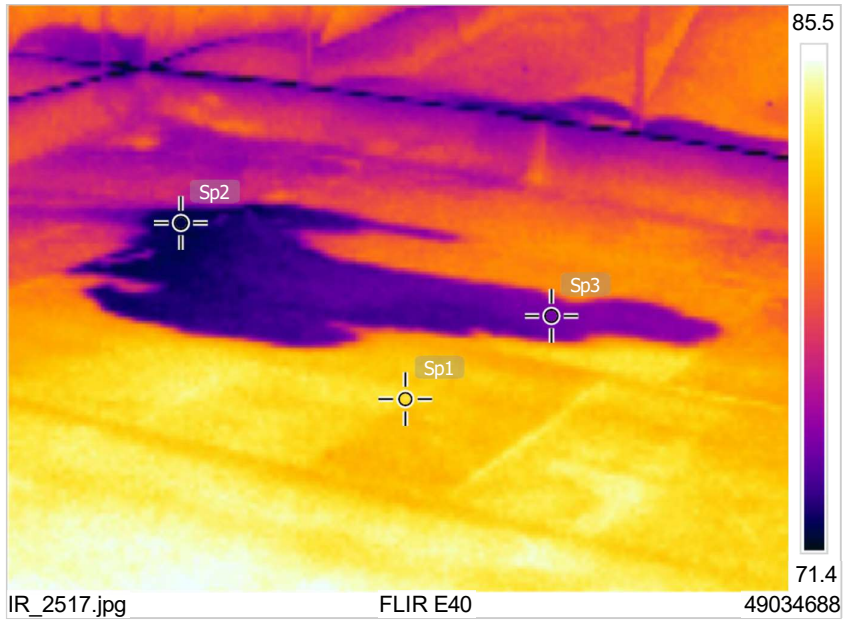
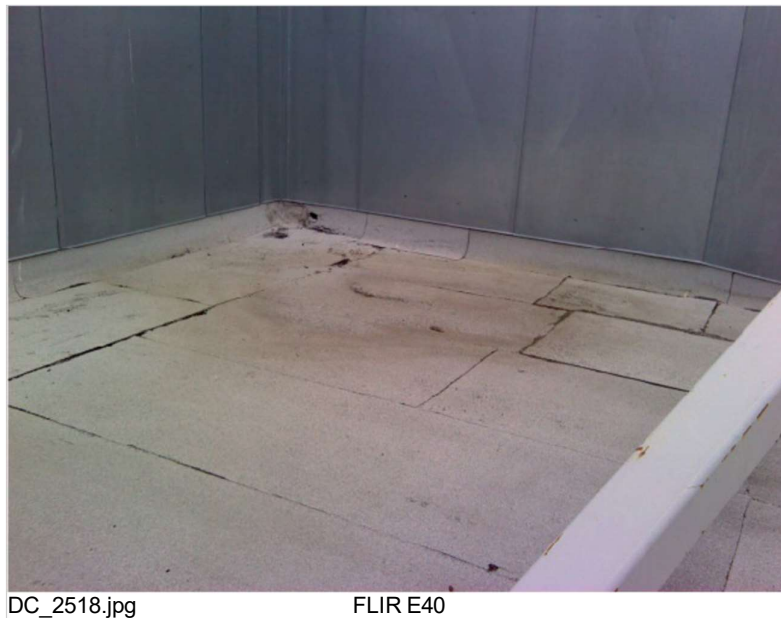
The following series of images were taken during the roofing system inspection. The roofing system is generally in good condition. There are several locations where moisture is accumulating. There is no standing water in this image. Thermography shows latent heat of vaporization where moisture is retained. Spot Tool 1 indicates the ambient temperature of the roofing material is 84.1F. Spot Tool 2 and 3 show the area is significantly cooler where moisture is retained.

Sp1	72.8
Sp2	82.9

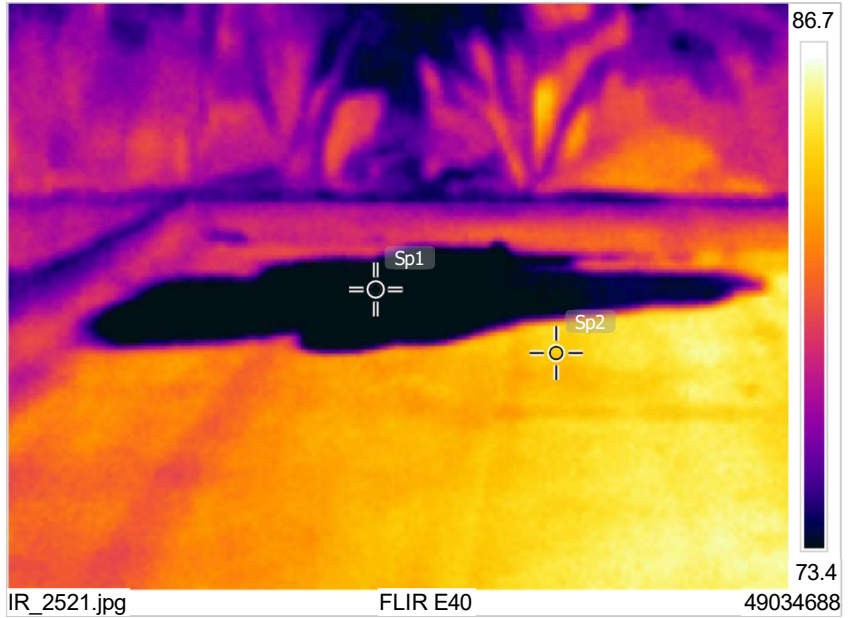
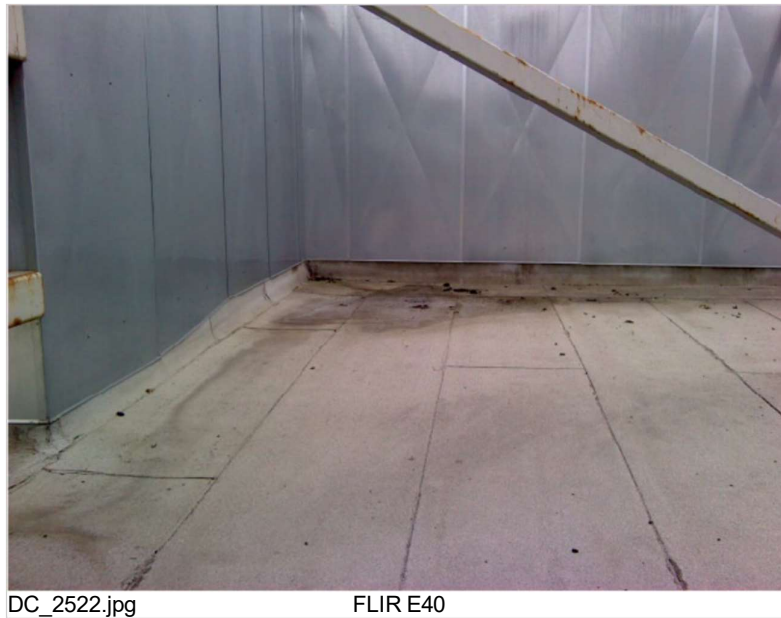
This image shows latent heat of vaporization in roofing materials.

Sp1	72.0
Sp2	84.9

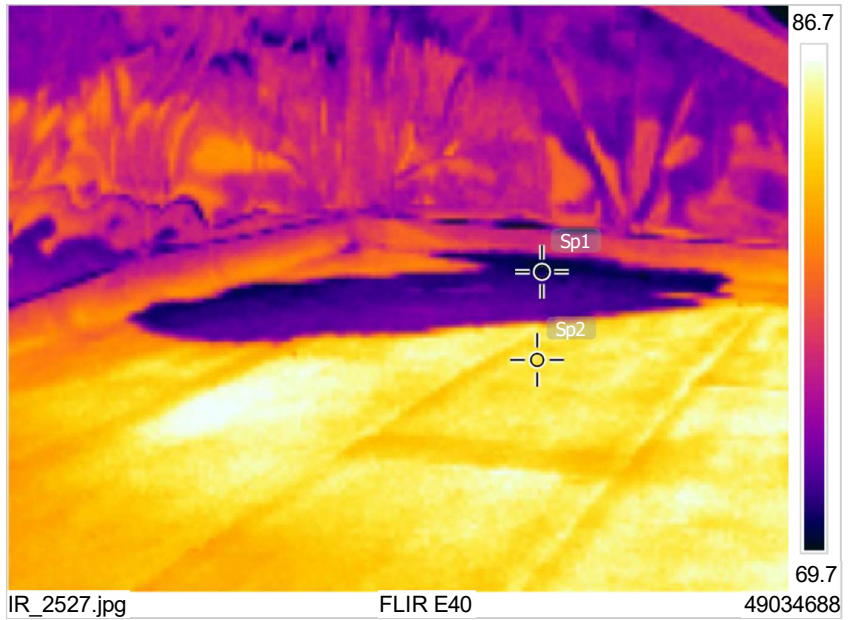
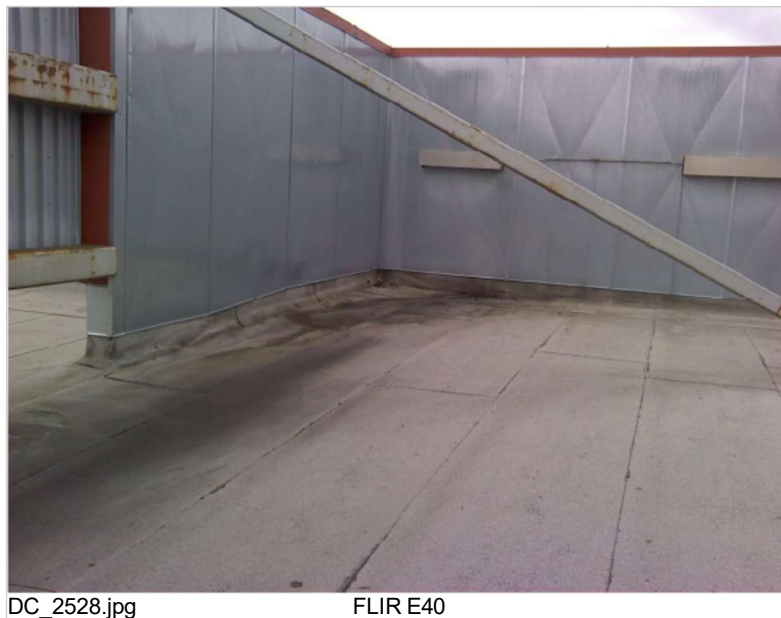
This image also shows moisture retention in roofing materials. Refer to architect report for recommended remediation.

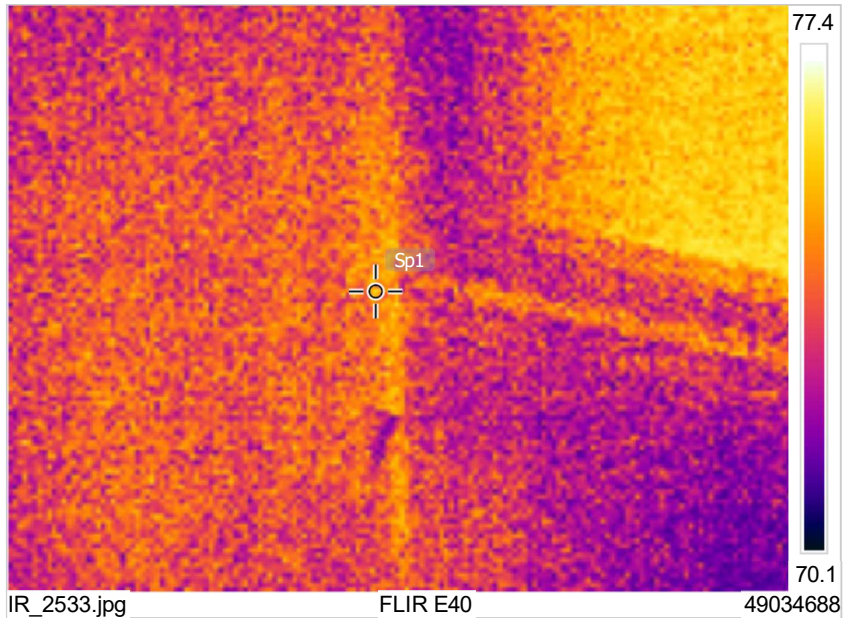
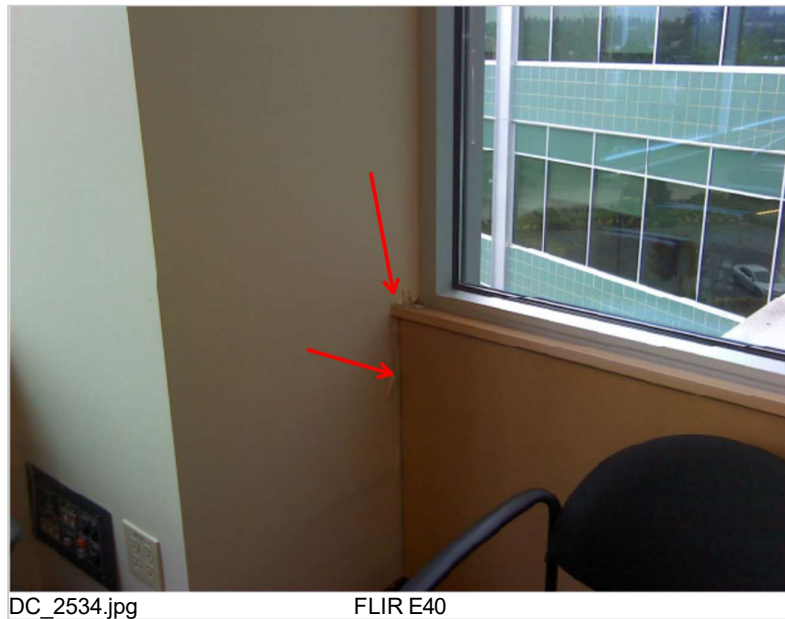
This image shows the location of a glazing leak. Thermography shows the area is dry. The digital images shows peeling paint where the condition occurs intermittently. There are several locations affected by this condition. Refer to architect report for recommended repair.

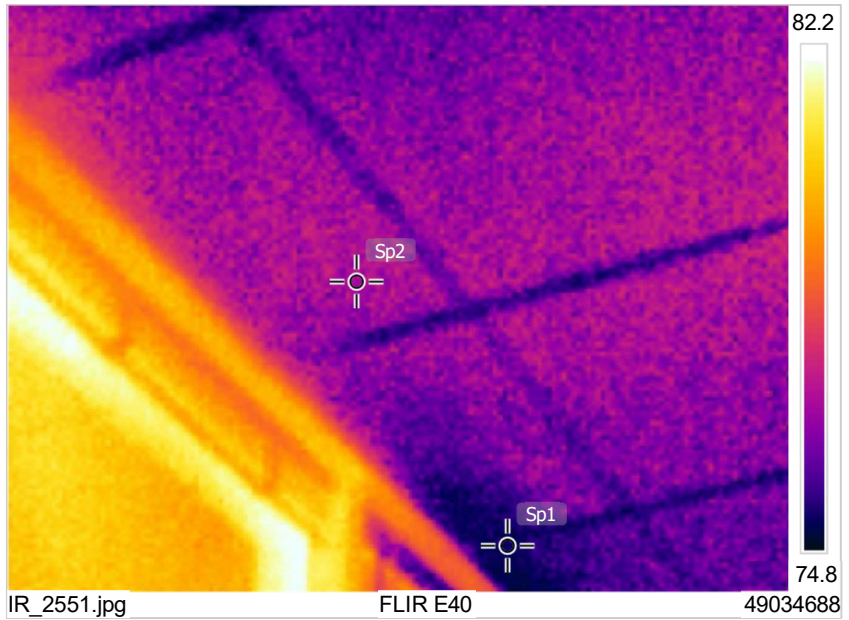
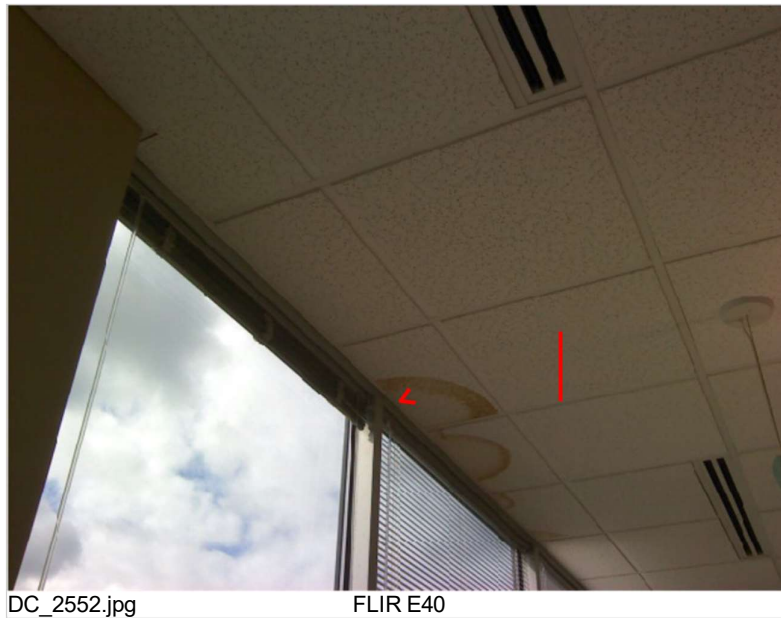
This image shows a building envelope or glazing leak. Spot Tool 1 shows moisture retention in these ceiling tiles.

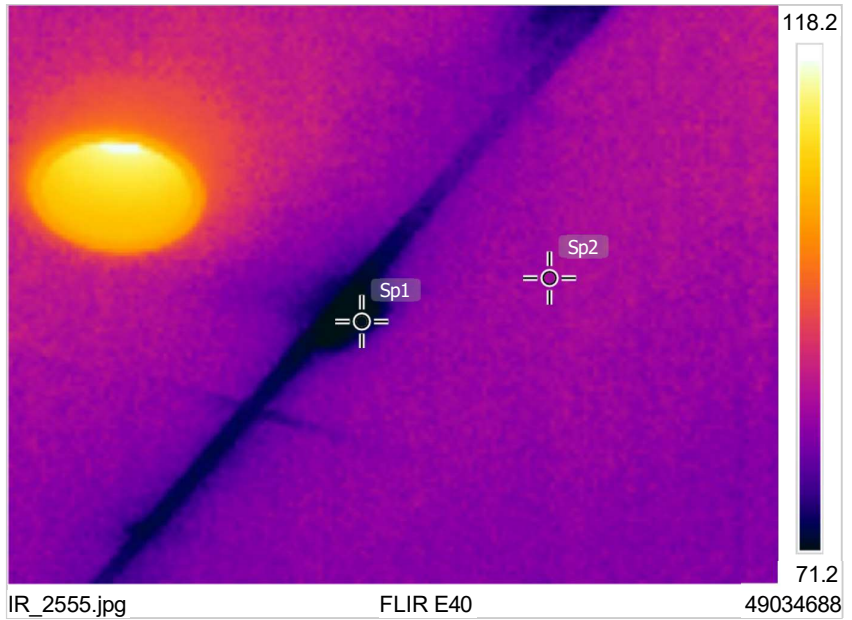
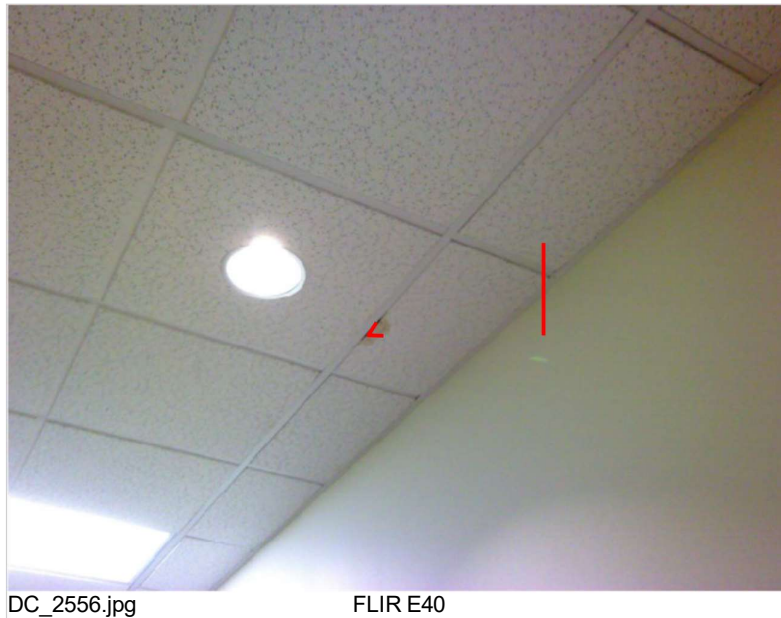
Spot Tool 1 shows an active hydronic piping leak. This is a maintenance item and occurs in several locations.

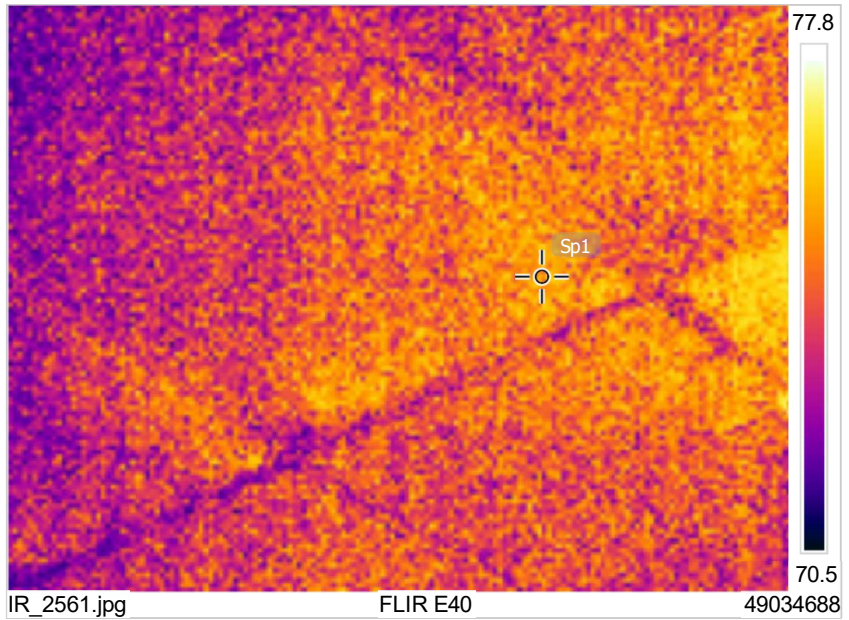
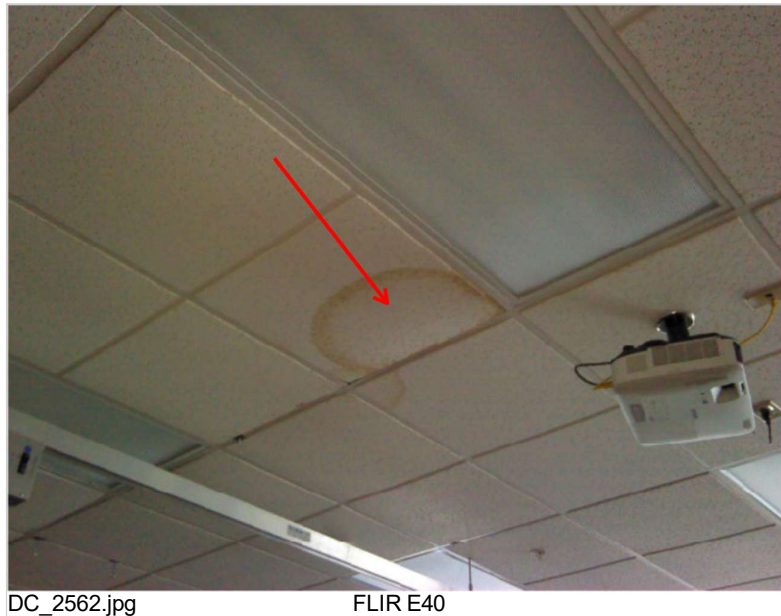
Inactive hydronic piping leak.

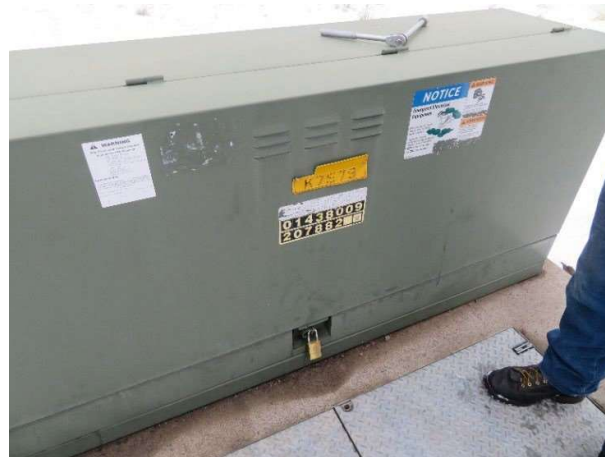
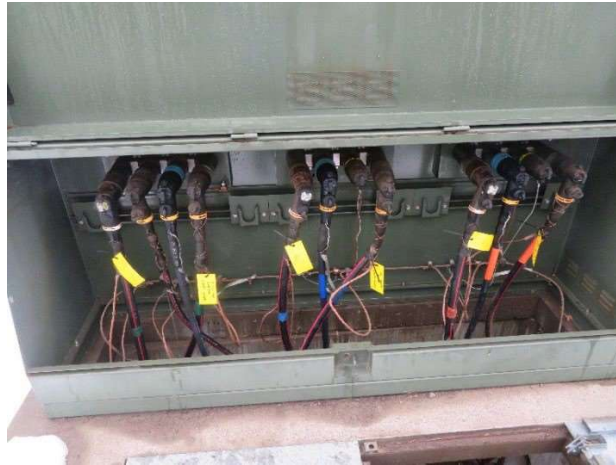
- No modifications needed

PRODUCTION WELL #5

Each well listed above is connected to the geothermal mechanical building's power distribution system. Refer to section 2.3.4 Geothermal Mechanical Building section below for further discussion.

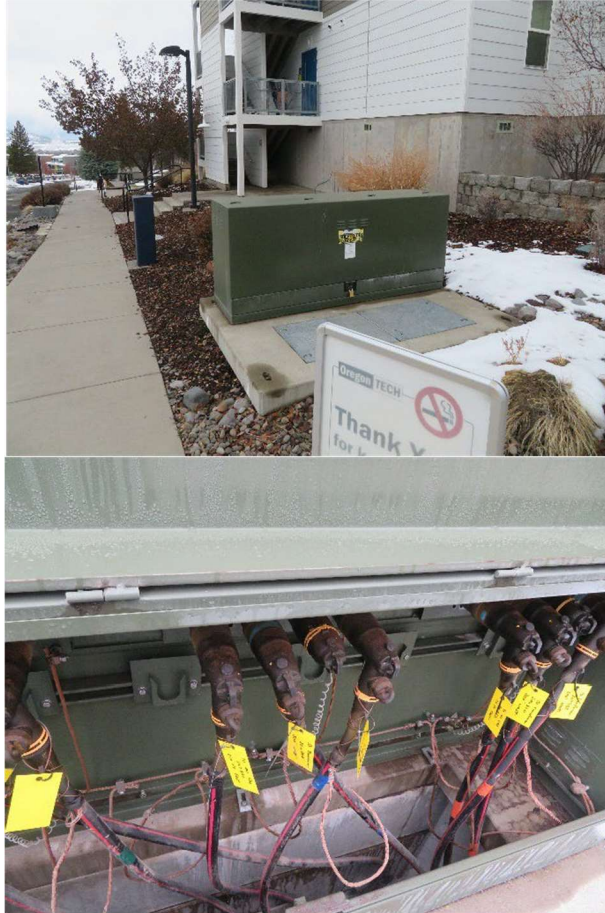
The building houses:

INJECTION WELL #1

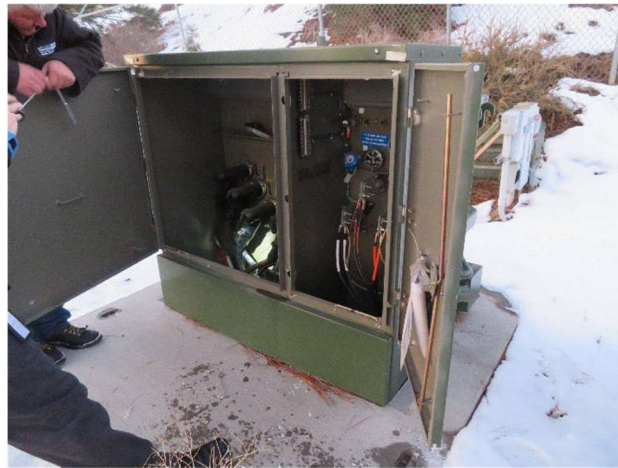
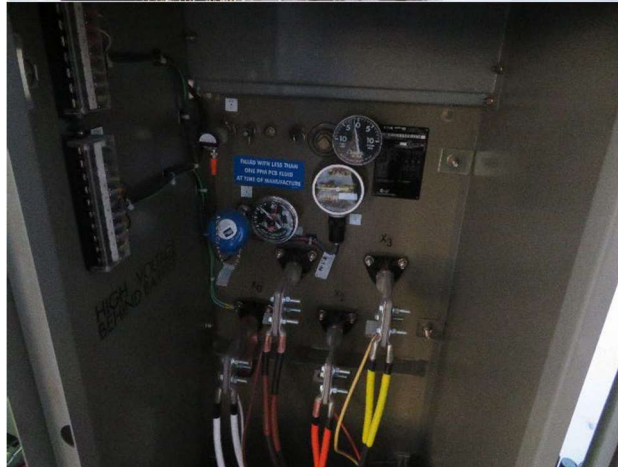
05.01.20.15 Stadium Transformer – Event 1

Good Condition. The Transformer supplies 480/277V to LRC and PE and is fed from the College Union Vista Gear. The Transformer was installed in January 2020, and still has substantial service life remaining. The transformer is a 750kVA 3-Phase 480/277V rated step-down transformer with a 5.94% impedance. If the Transformer fails, LRC and PE will experience an outage.

Event Type	Event Year	Event Cost	Priority	Data Origin
Testing	Annually	TBD – Existing Service Contract	Low	Field Observations

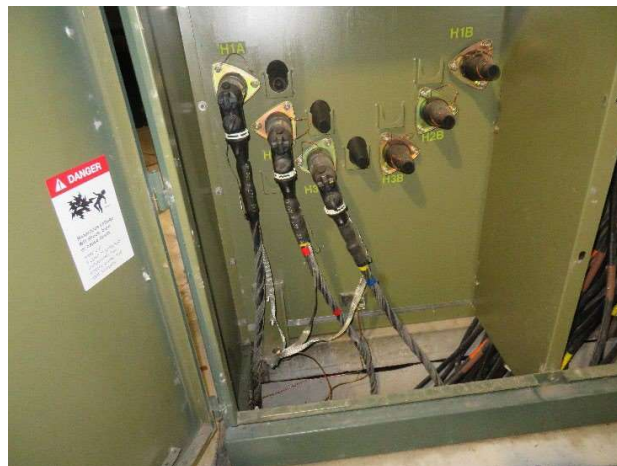
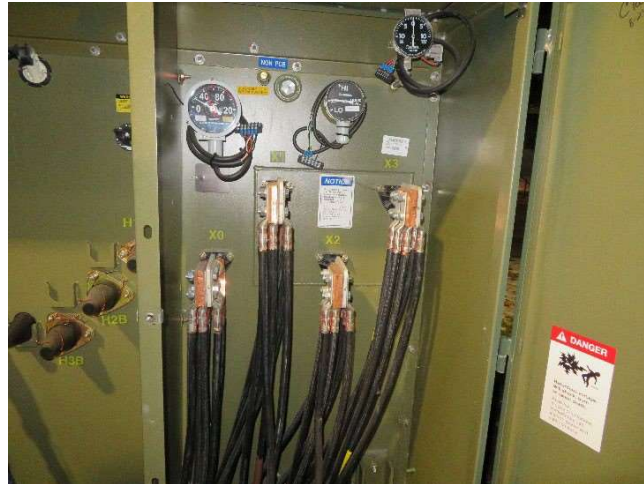
05.01.20.16 LRC & PE Transformer – Event 1

Condition Assessment Good Condition. The Transformer supplies 480/277V to Cornett and is fed from the Cornett Vista Gear. The Transformer was installed in January 2020, and still has substantial service life remaining. The transformer is a 1500kVA 3-Phase 480/277V rated step-down transformer with a 5.9% impedance. If the Transformer fails Cornett will experience an outage.

<i>Event Type</i>	<i>Event Year</i>	<i>Event Cost</i>	<i>Priority</i>	<i>Data Origin</i>
Testing	Annually	TBD – Existing Service Contract	Low	Field Observations

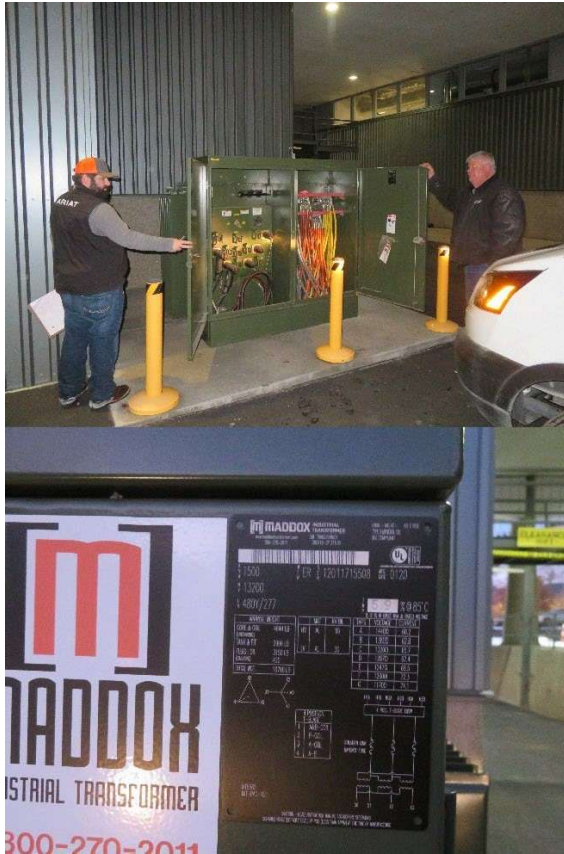
05.01.20.17 Cornett Transformer – Event 1

Good Condition. The Transformer supplies 480/277V to Facilities and is fed from the Cornett Vista Gear. The Transformer was installed in January 2020, and still has substantial service life remaining. The transformer is a 3-Phase 480/277V rated step-down transformer with a 5.0% impedance. If the Transformer fails, Facilities experience an outage.

Event Type	Event Year	Event Cost	Priority	Data Origin
Testing	Annually	TBD – Existing Service Contract	Low	Field Observations

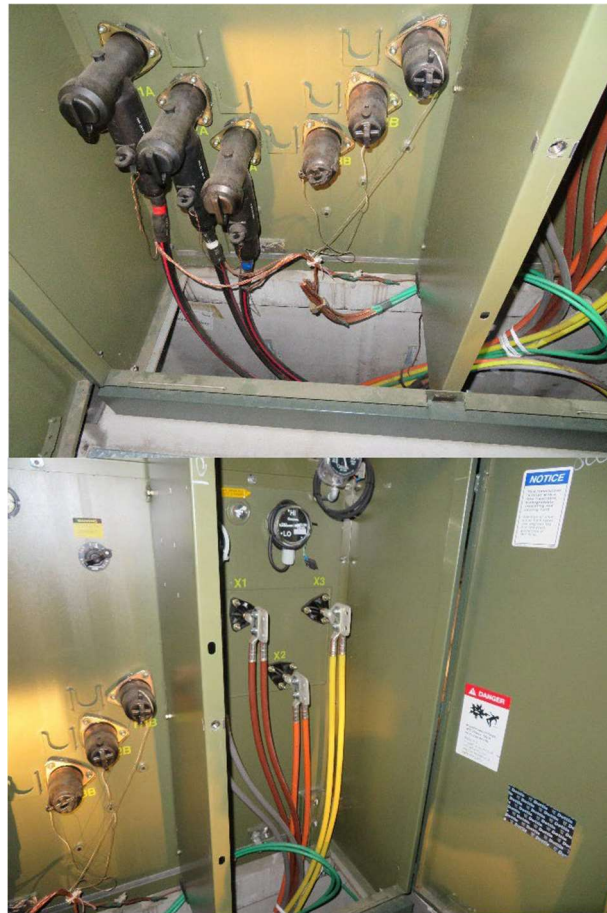
05.01.20.18 Facilities Transformer – Event 1

occur at MDP. If so, this is a code violation and should be corrected.

Event Type	Event Year	Event Cost	Priority	Data Origin
Repair	2023	\$1000	High	Field Observations

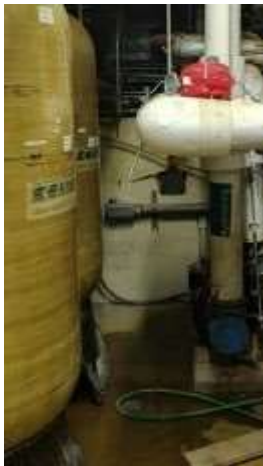
Element State: Poor

11.30.07.01 Booster CHW Pump (P-8) Event 1

Event Type	Event Year	Event Cost	Priority	Data Origin
Repair	2023	\$30,000	High
